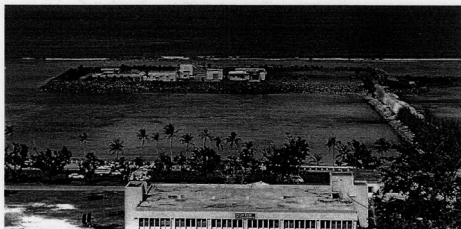
There are two critical aspects to waste water treatment. One is the transport of the sewage to the treatment plant. The second is the actual treatment of the sewage and disposal of the effluent. The lack of power has affected lift stations and pumps that allow smooth flow of the sewage to the treatment plants. Most of the critical lift stations and pumps have emergency generators, but as with the water system, the emergency generators are not designed to operate for long periods of time. The most vulnerable of the treatment plants is the one at Hagåtña, which is susceptible to storm surge and wave damage. There was some damage to the access road during Typhoon Paka.

Figure 8.1. Hagåtña waste water treatment plant. The access road (right side of picture) was damaged during Typhoon Paka. The Agana Boat Basin is to the right of the access road.

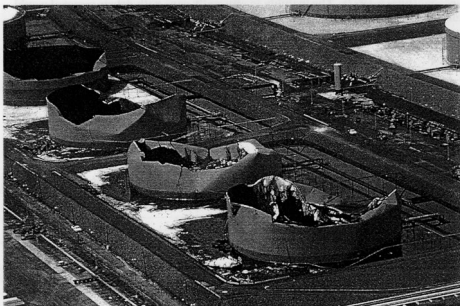
Figure 8.8. Damage to fuel storage tanks in the U. S. Virgin Islands during 160 mph sustained wind from Hurricane Hugo.

Figure 8.8 shows the damage incurred to partially filled fuel storage tanks in the U. S. Virgin Islands during 160 mph sustained winds (weak Typhoon Category 5 winds) from Hurricane Hugo in 1989.
