APPENDIX A

Color Figures

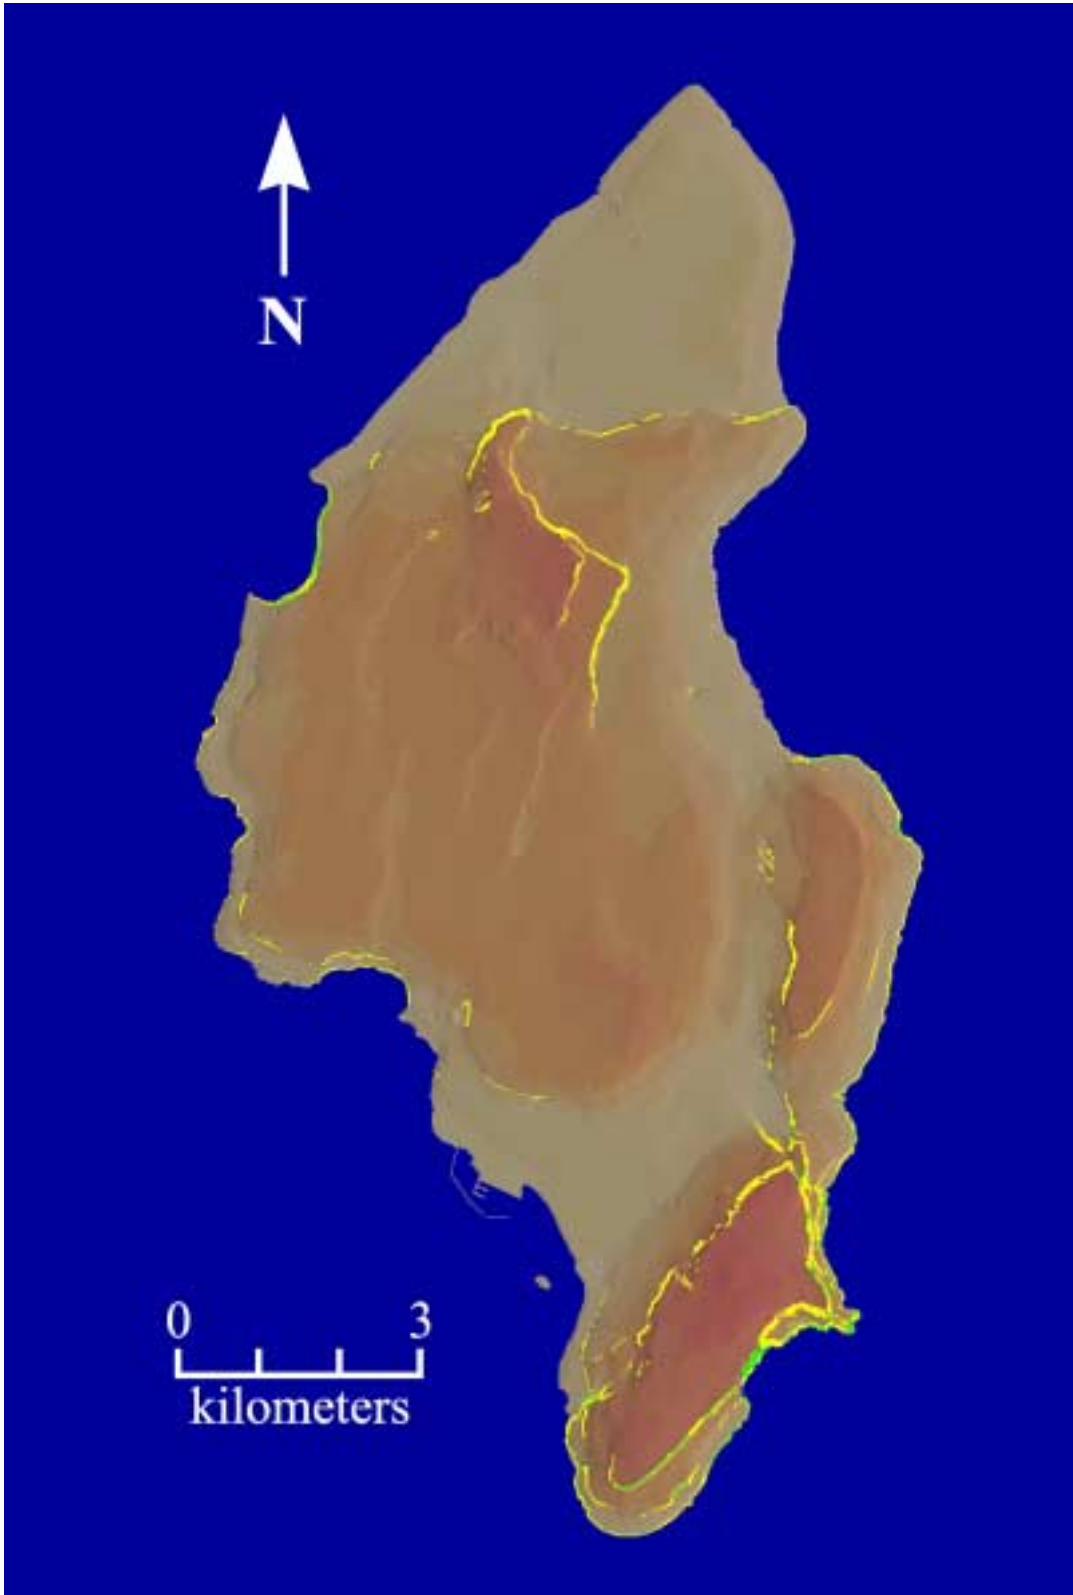
Figure 19: Inland and coastal scarps on Tinian.

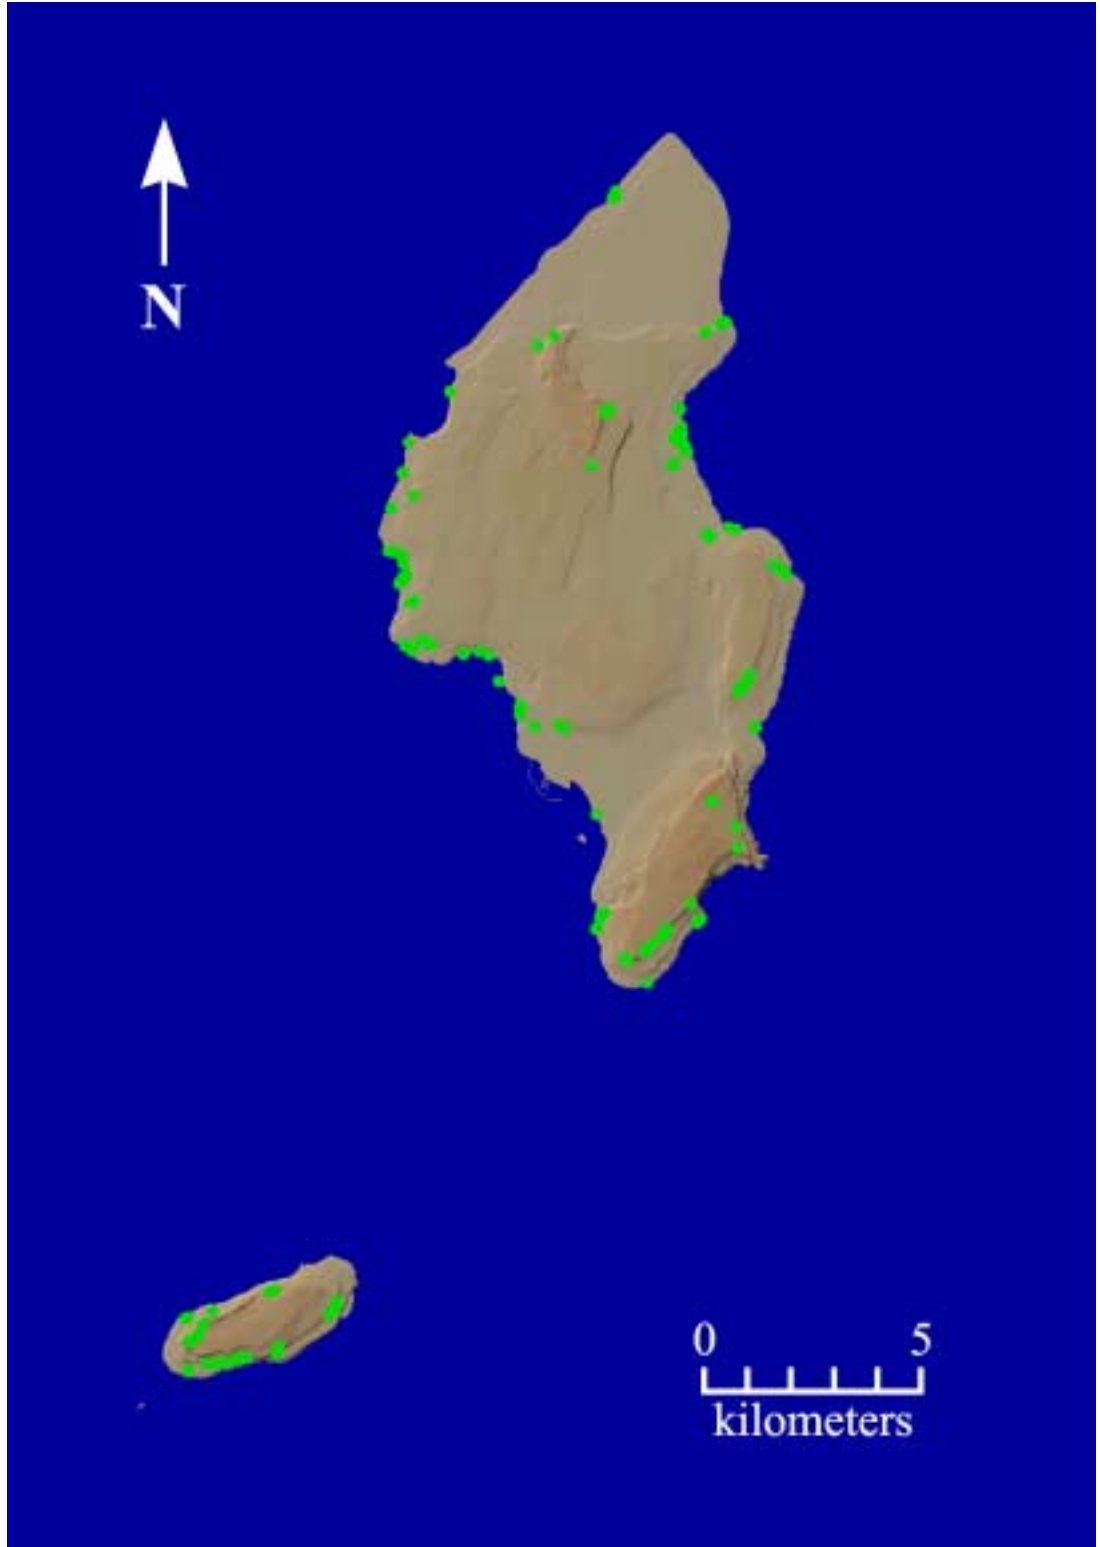
Figure 23: Green areas represent the location of cave and karst features surveyed on Aguijan and Tinian.

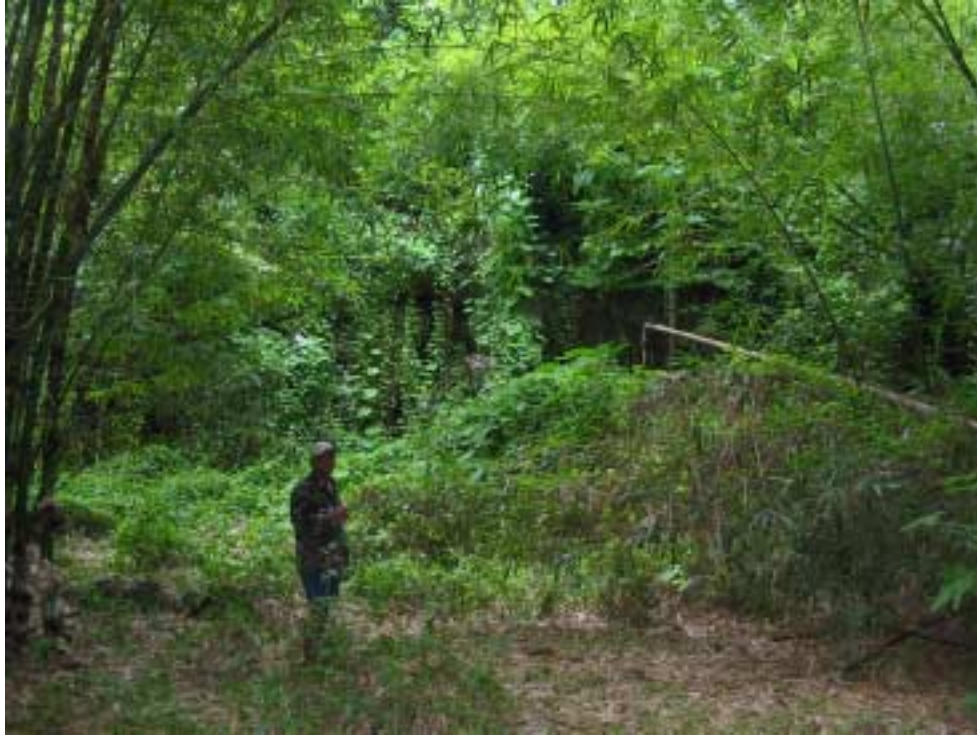
Figure 25: Bamboo growing in the North Lemmai Recharge Feature, with vines coating the scarp that forms the non-carbonate / carbonate contact.

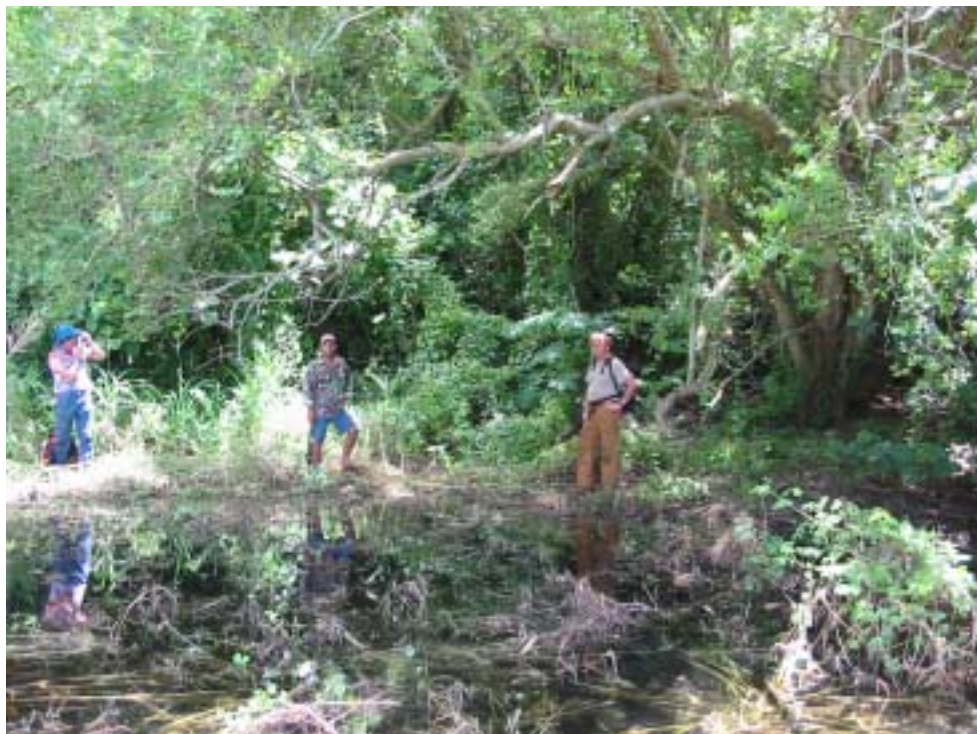
Figure 26: Ponded water in the South Lemmai Recharge.

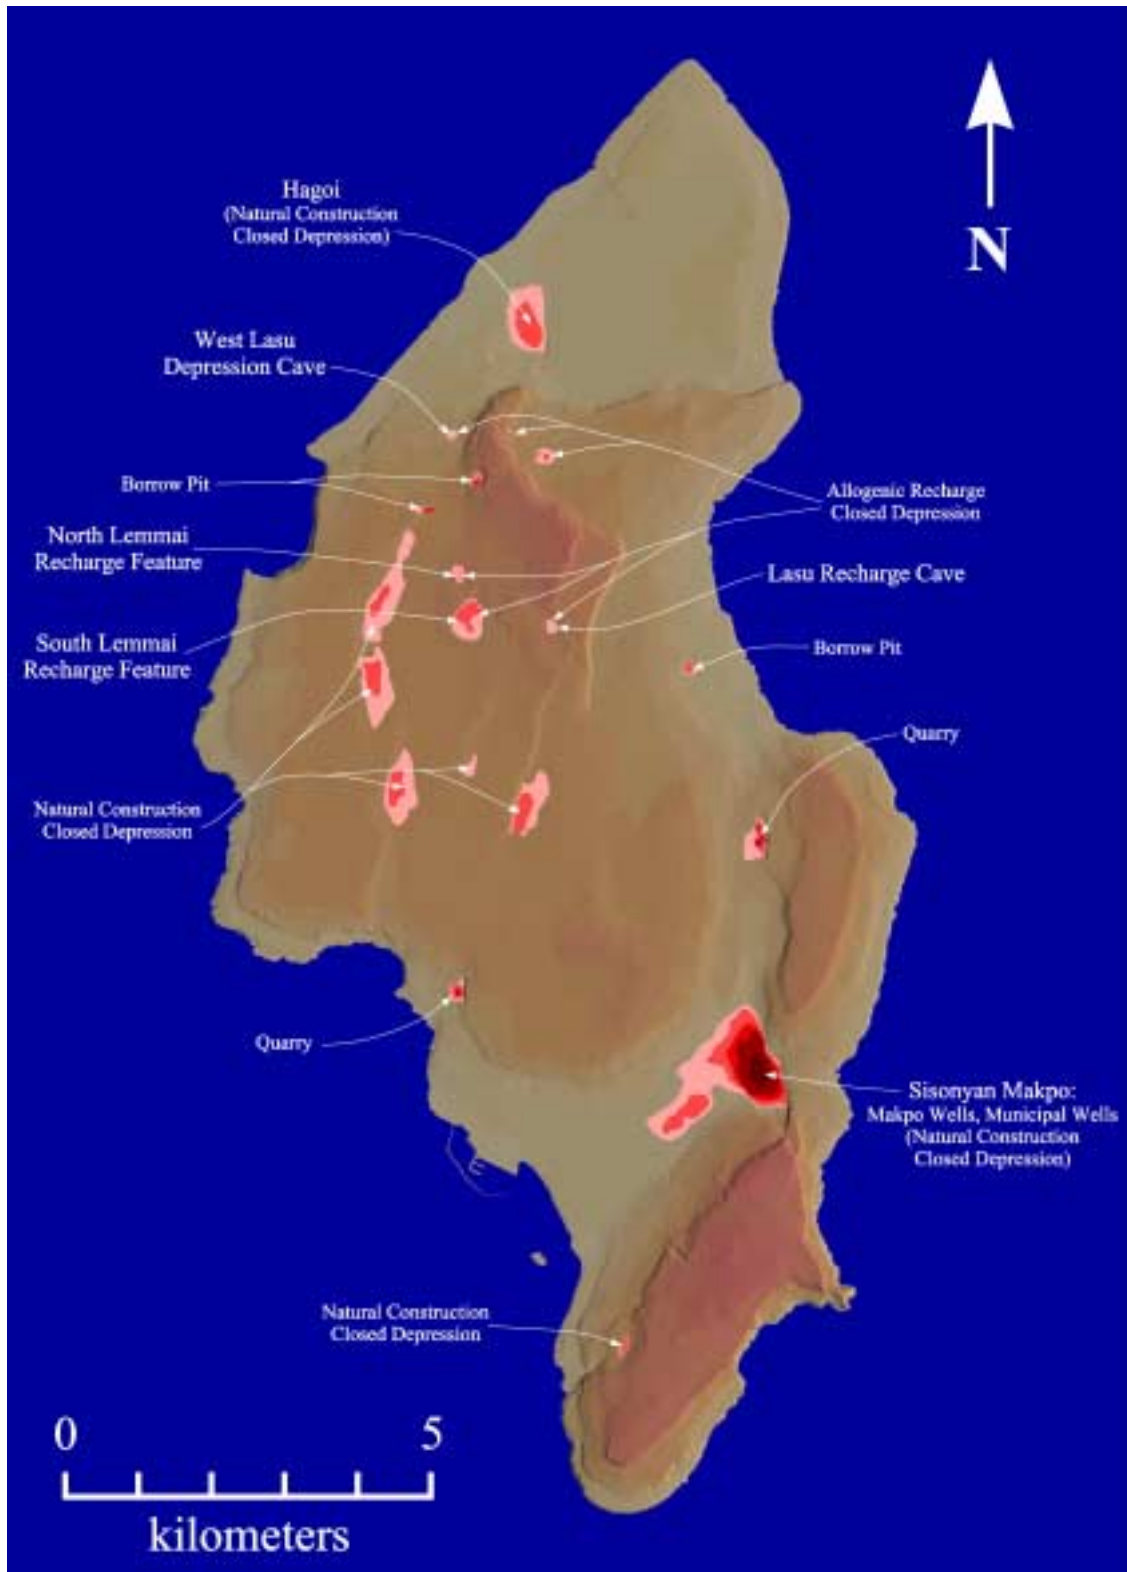
Figure 27: Location of closed depressions on Tinian.

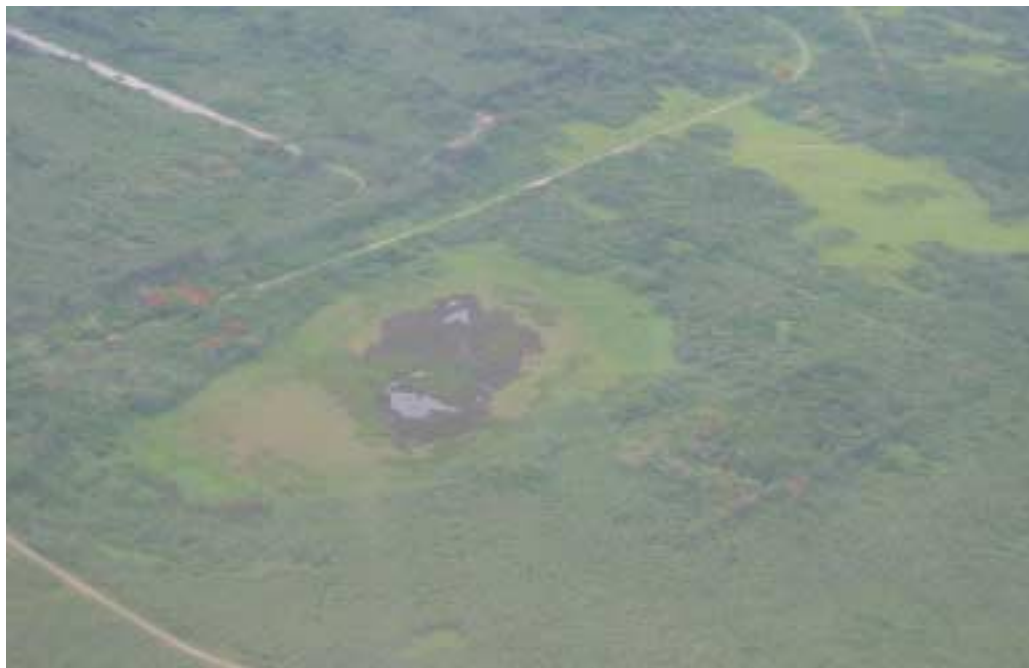
Figure 29: Fresh-water at the land surface (~2 meters above mean sea level) at Hagoi in the Northern Lowland.

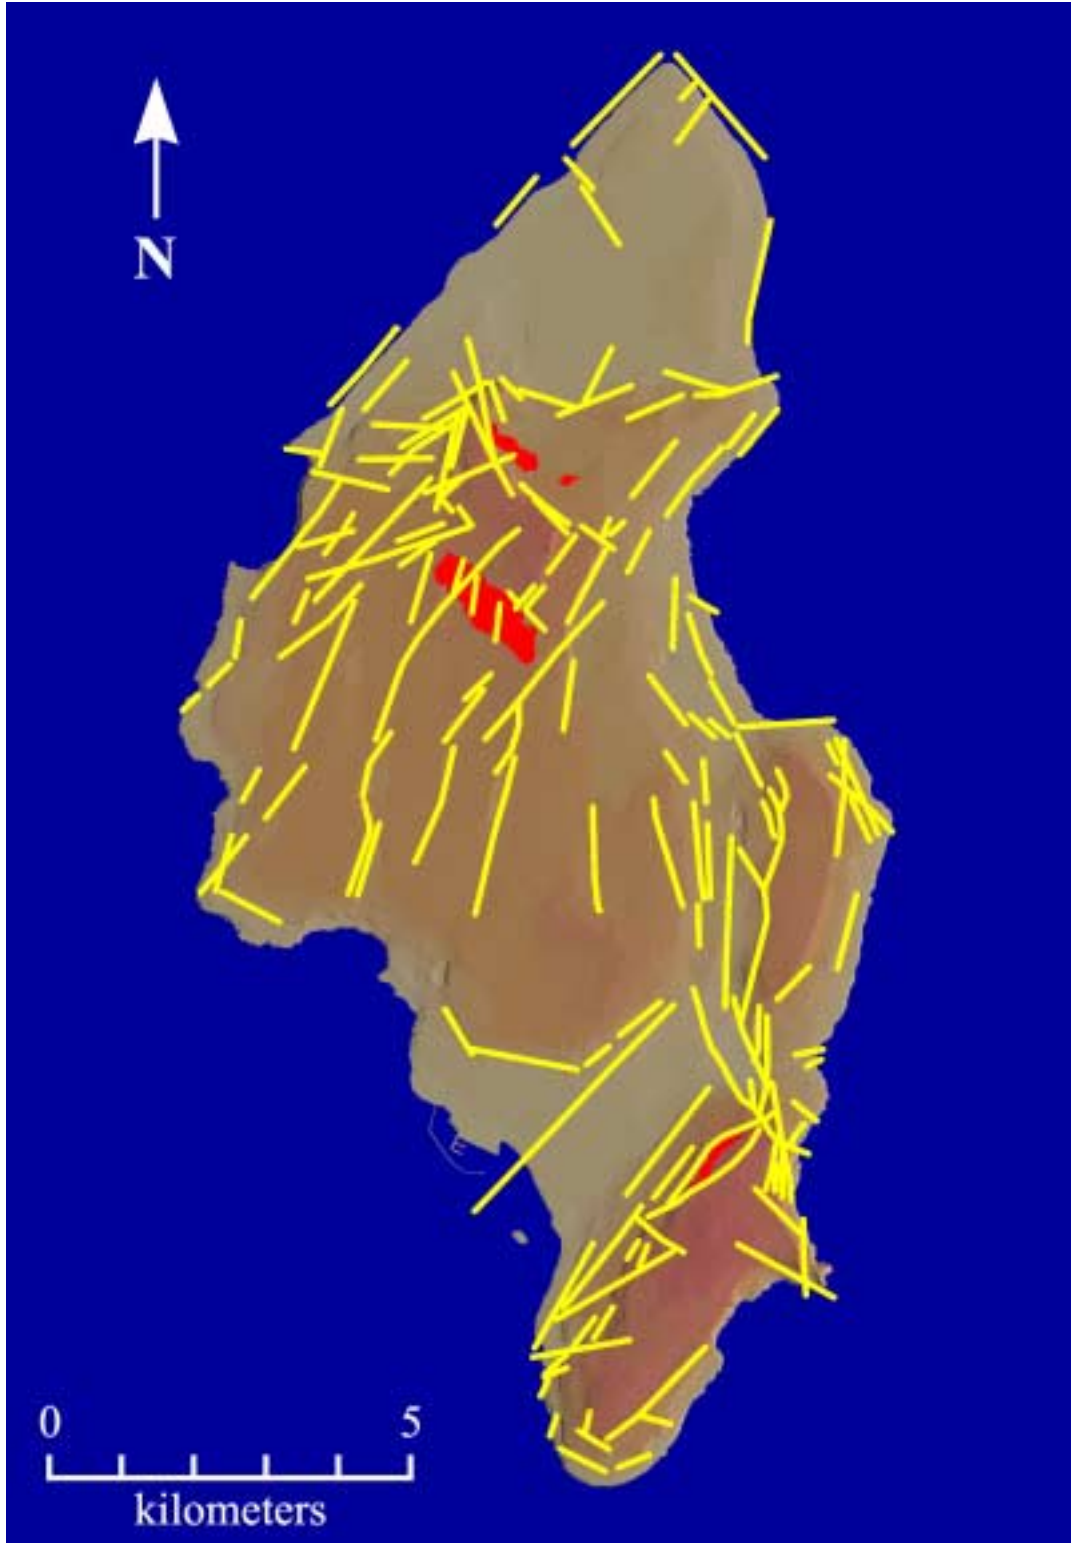
Figure 30: Faults (yellow) and non-carbonate rock outcrops (red) reported by Doan and coworkers (1960).

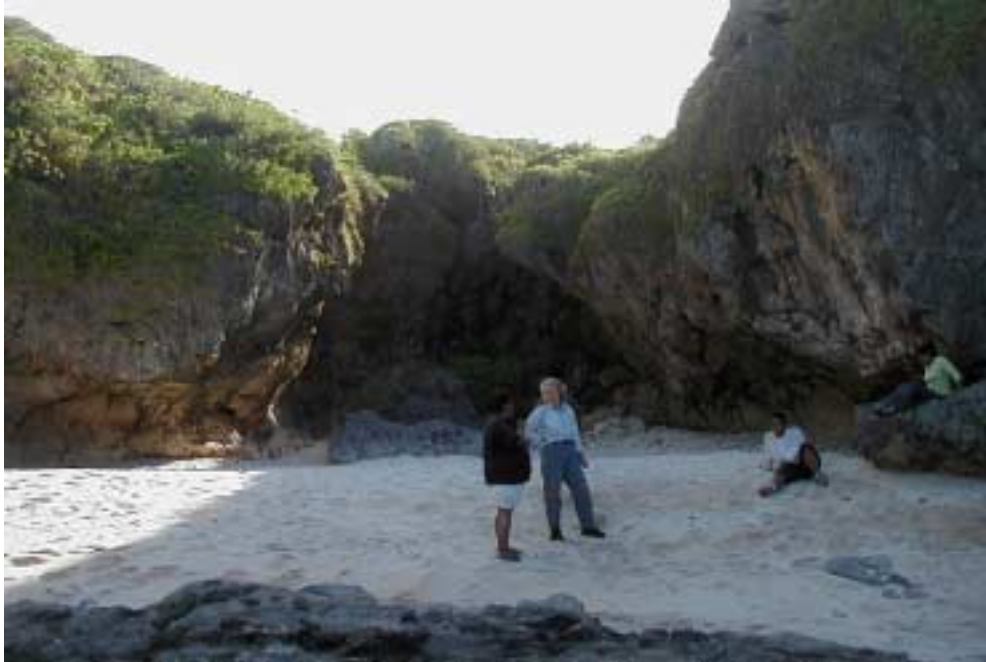
Figure 31: South Unai Dangkolo represents a typical cove that has formed from collapse and coastal erosion of a large flank margin cave.

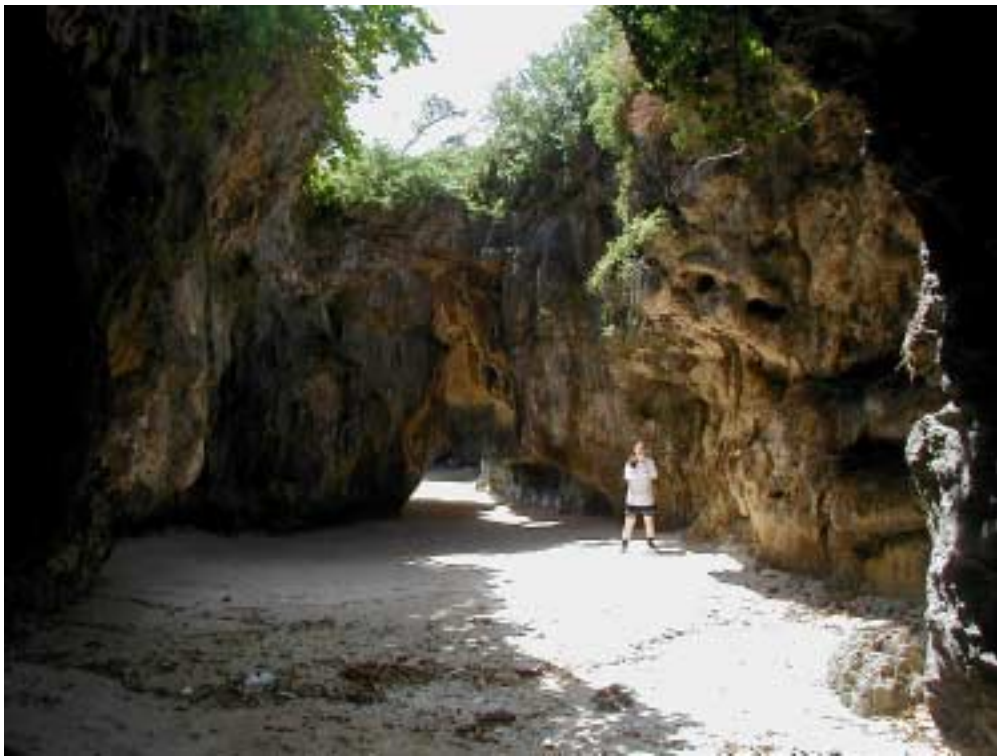
Figure 32: Hidden Beach Cave demonstrates well the transition from flank margin cave to cove resulting from coastal erosion.

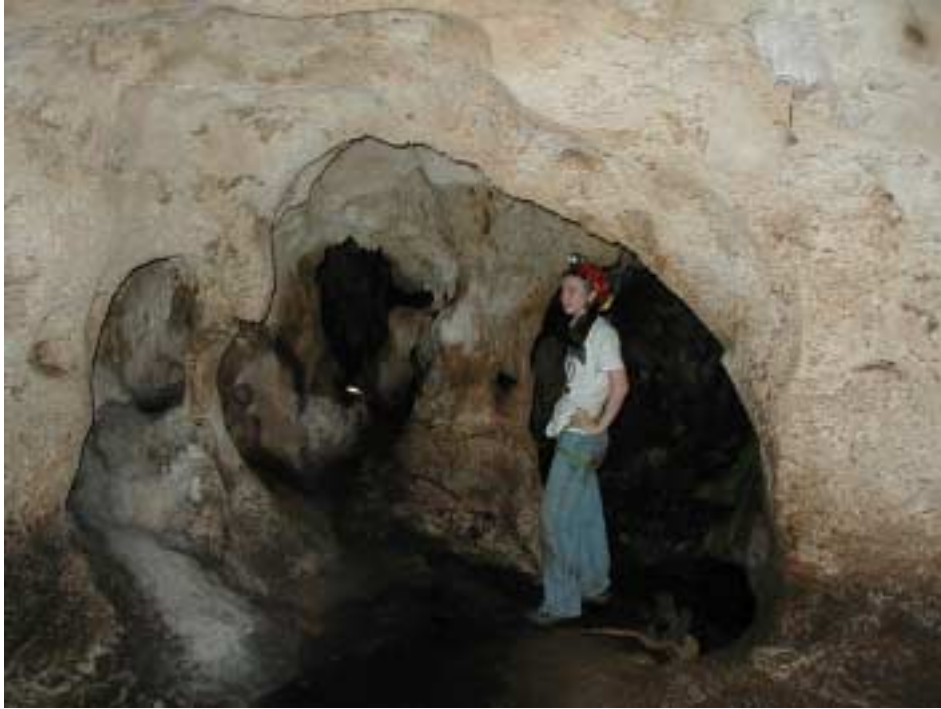
Figure 33: Typical flank margin cave morphology in one of the passages extending from the main chamber in Unai Dangkolo.

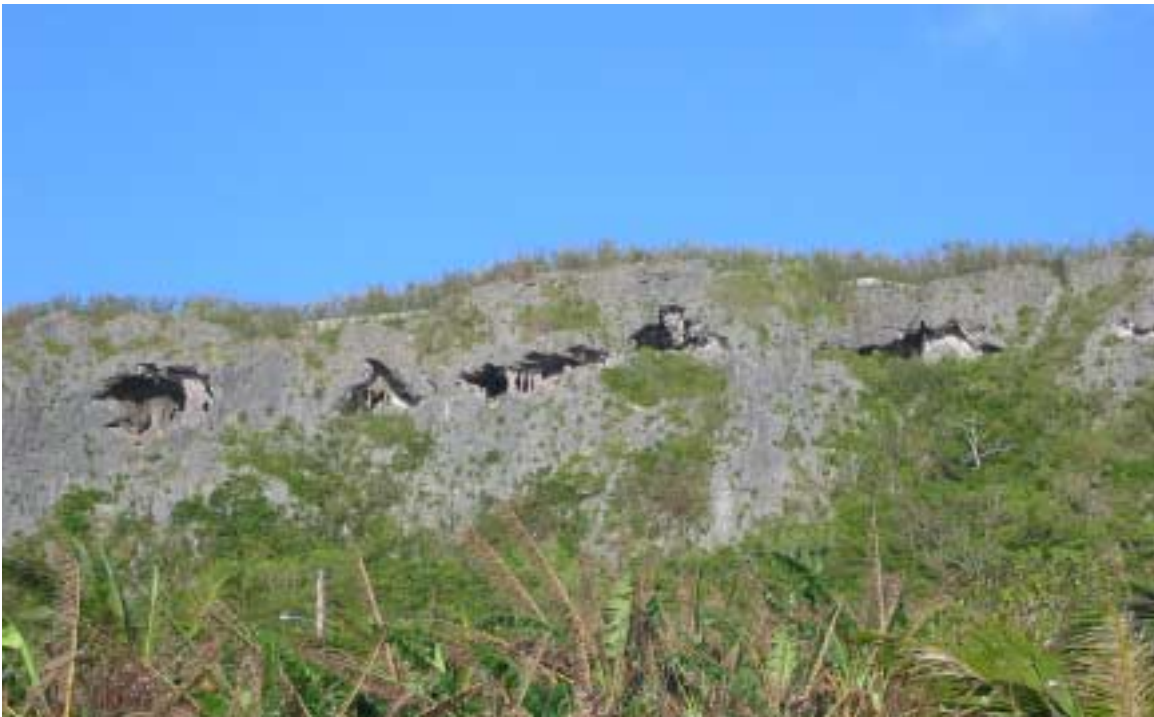
Figure 34: Horizons of flank margin cave development show previous fresh-water lens positions as seen at Suicide Cliffs, Tinian.

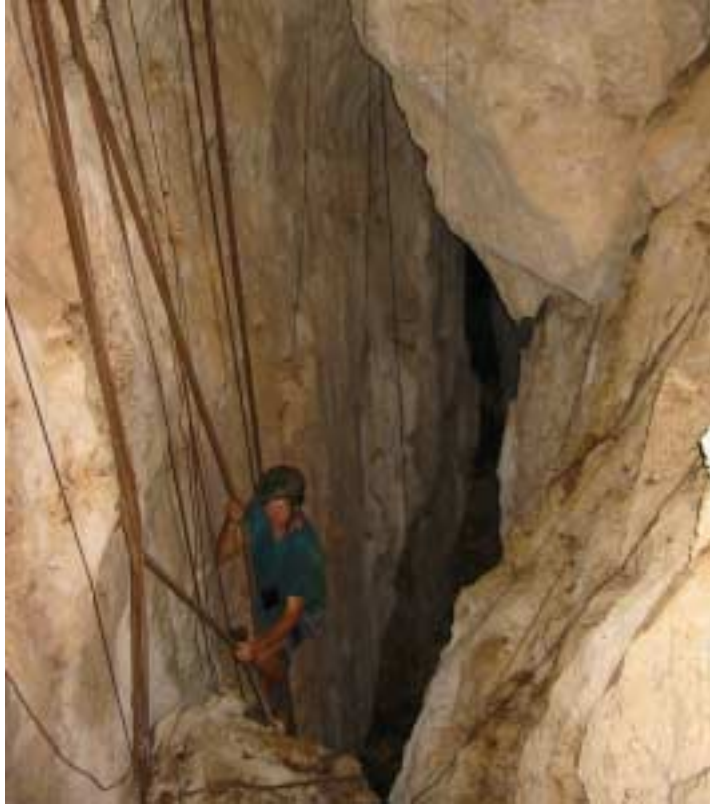
Figure 35: Fissure caves form narrow, linear passages that appear to be developed along zones of brittle failure as seen in Carolina's Fracture Cave.

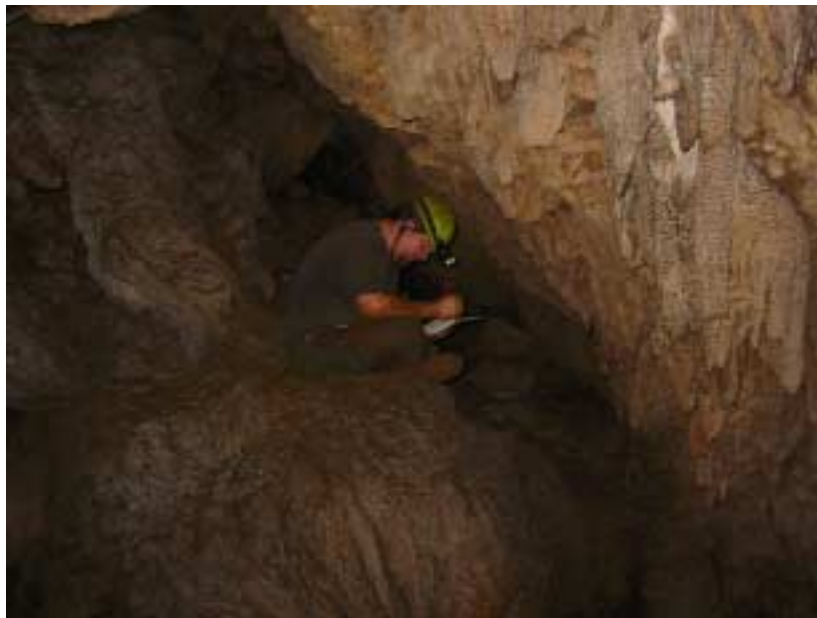
Figure 36: Flowstone deposits on ceilings and walls prevent observation of offsetting of rocks by faulting if it exists (Plunder Cave, Tinian).

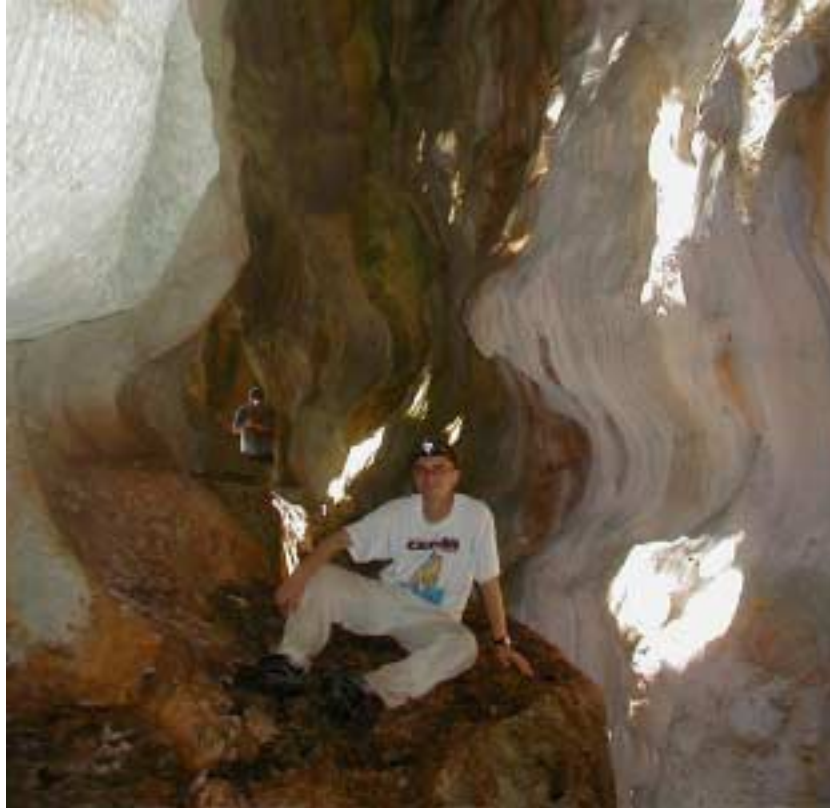
Figure 37: Insect Bat Cave on Aguijan represents a paleo-discharge feature.

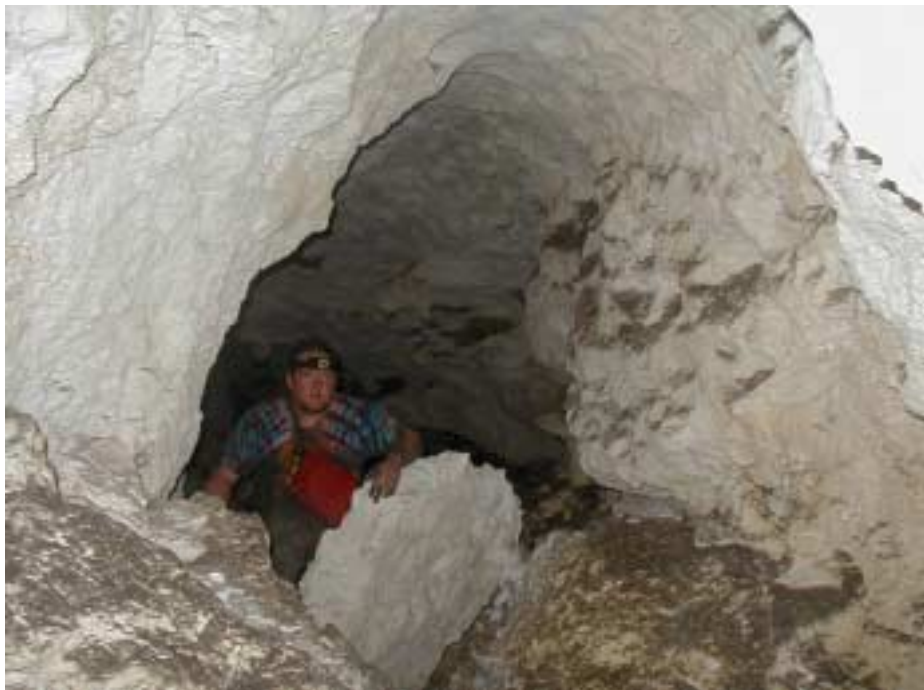
Figure 38: Scallops on the ceiling and walls of Liyang Atkiya, Aguijan.

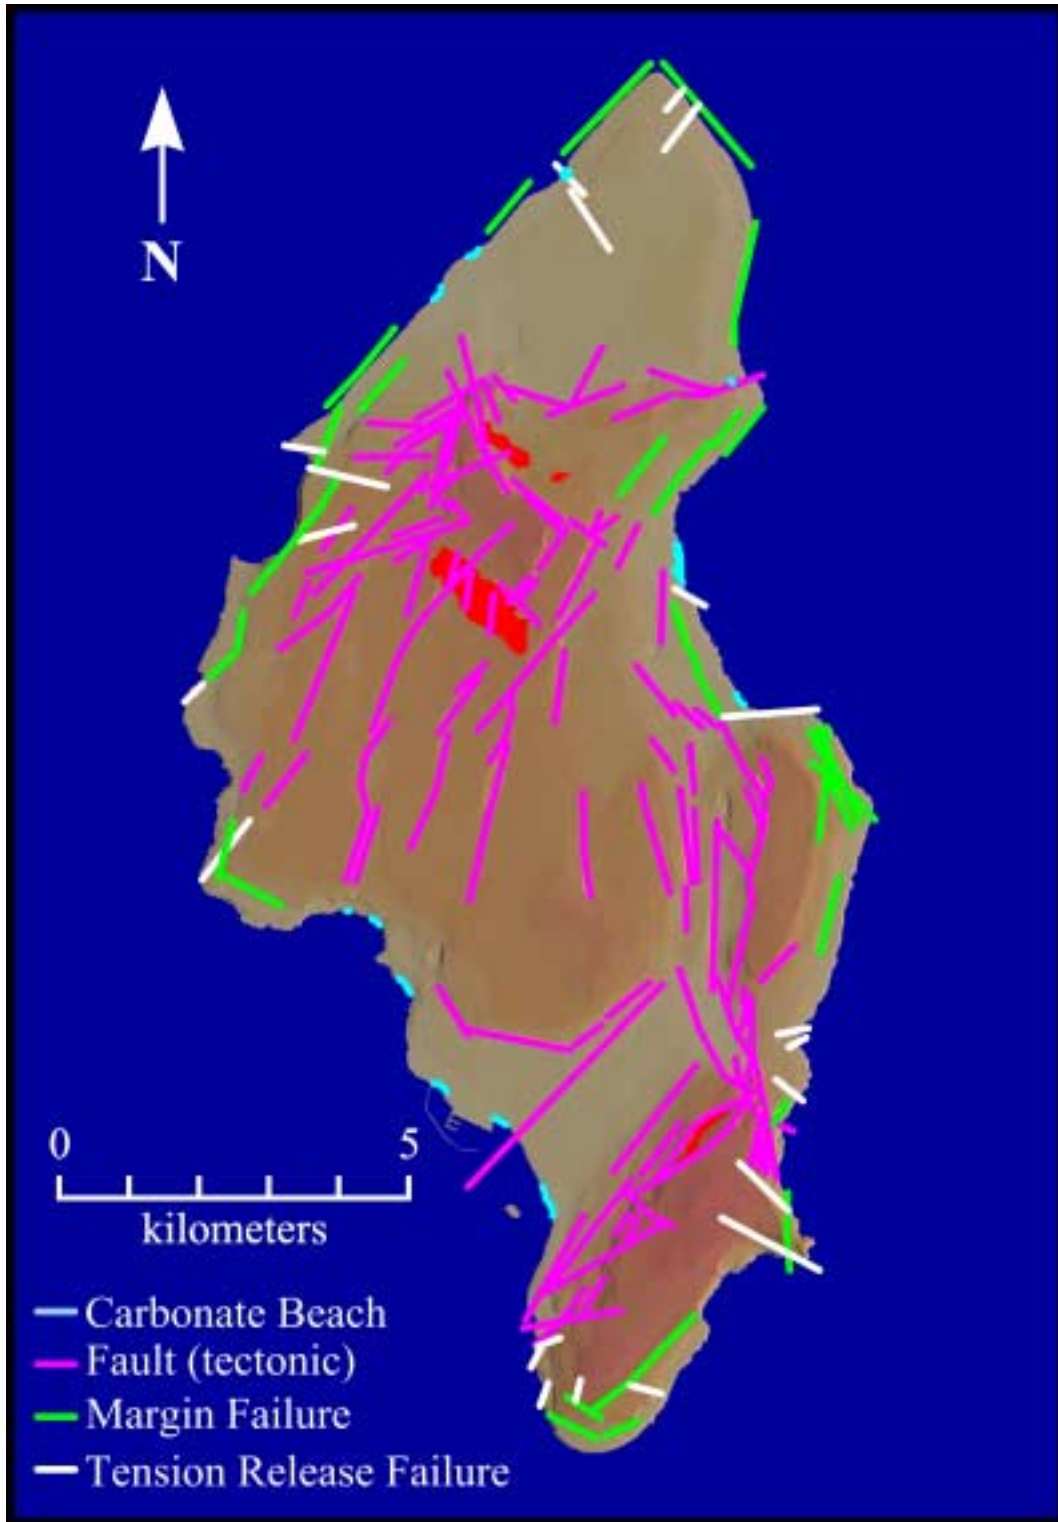
Figure 39: Diagram showing the location of modern carbonate beach deposits (light blue) and primary brittle failure types: tectonic faults (purple), margin failures (green) and tension release failures (white) (adapted from Doan et al., 1960).
