**ENVIRONMENTAL
ASSESSMENT FOR
NON-POINT SOURCES
OF POLLUTION FOR
UGUM WATERSHED**

**WATER AND ENVIRONMENTAL RESEARCH INSTITUTE
OF THE WESTERN PACIFIC
UNIVERSITY OF GUAM**

**Technical Report No. 109
December 2005**

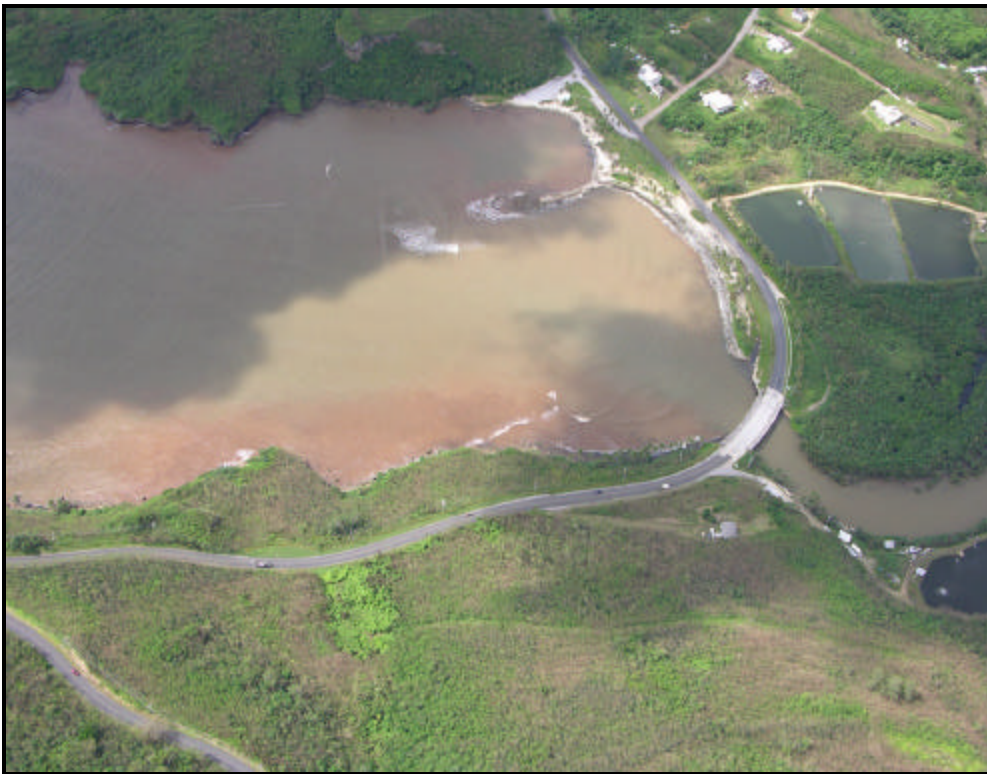
Figure 4. Talofofu Bay after heavy rainfall event. The bay is choked by sediment washed down from the Talofofu and Ugum River systems.

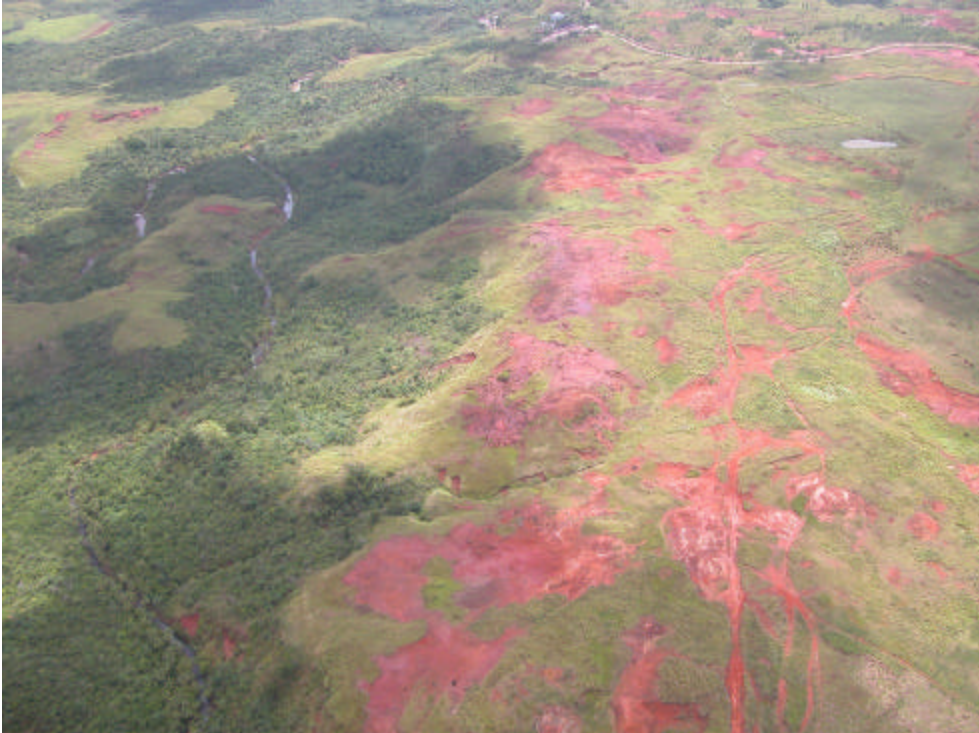
The total badland area within Ugum Watershed was estimated to be 168 acres or 3.6% of the entire watershed. This estimation is based on summing up the badland areas that were identified by WERI researchers using the 1993 aerial photos of the southern Guam. A study that was completed by Khosrowpanah et al, 2002, indicated that badlands across the steepest slopes of the watershed contribute an average of 65.90 tons/acre/year in soil yield. Comparably, badlands from lower lying, less steep areas of the watershed averaged 13.70-tons/acre/ year in sediment yield. Figures 8a and 8b shows the location of the badlands within the Ugum Watershed.

Figure 8a. Badlands within the Ugum Watershed.

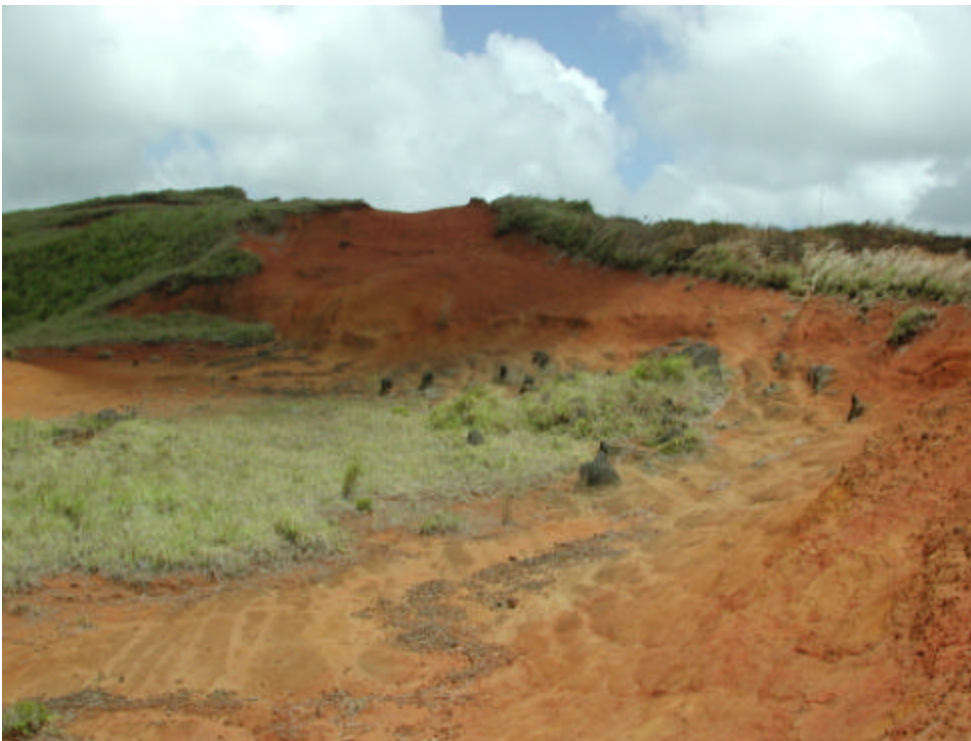
Figure 8b. Badlands within the Ugum Watershed, a close up view.

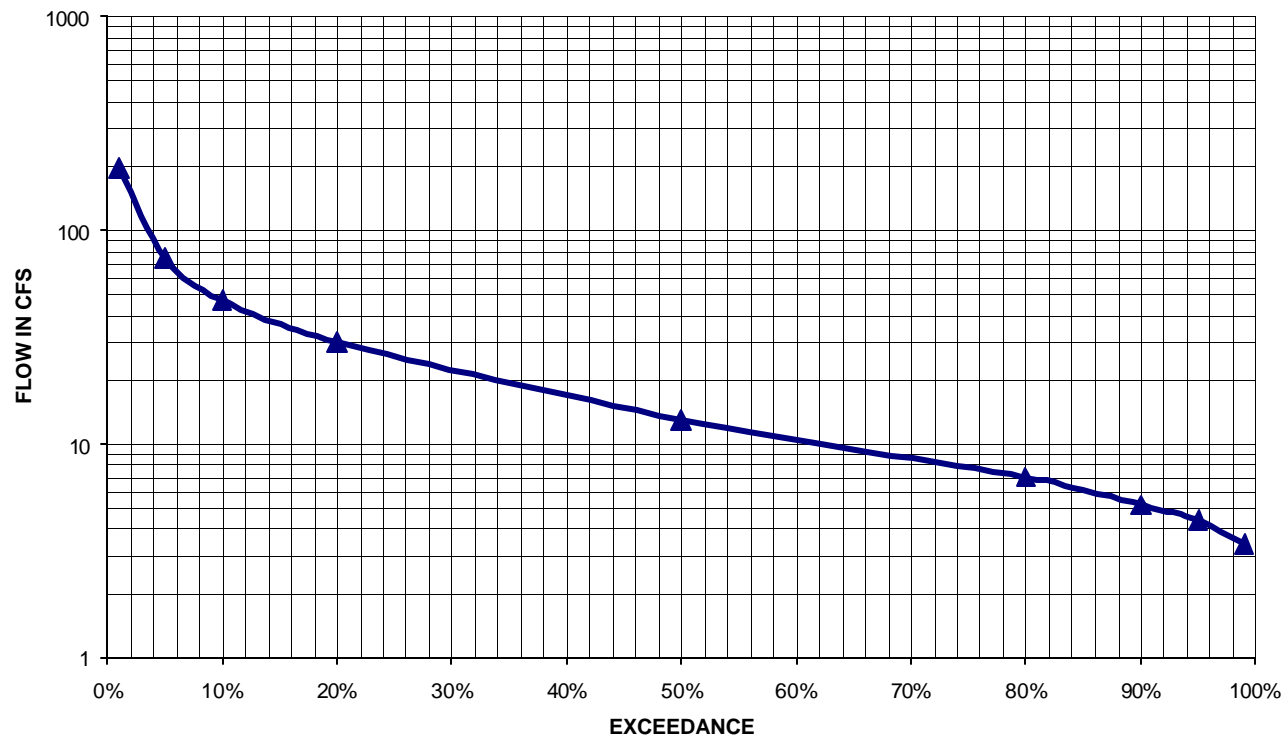
Flow Duration Curve
Ugum River, USGS Gage Station 16854500, 1977-2000

Figure 9. Flow Duration Curves, Ugum River at USGS Gage Station 168545.

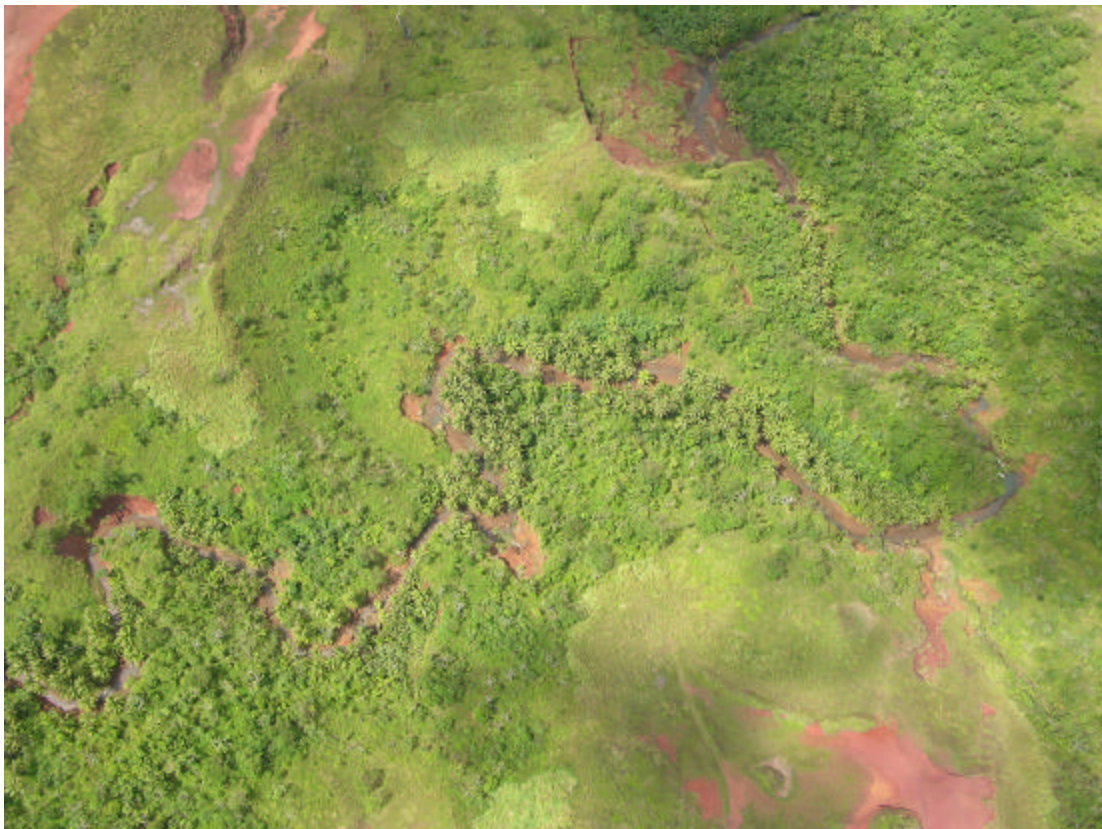
Bank erosion, which erodes the channel laterally, is due to the two processes; fluvial entrainment and weakening and weathering (Throne 1982). Fluvial entrainment increases the bank erosion by the shear stress generated in the river flow and cohesiveness of the bank materials. As the flow velocity increases the shear stress on the bank will increase (Ritter, 1986) and the rate of bank erosion increases. The weakening and weathering tend to reduce the strength of bank materials and thereby promote instability and failure. The mechanics of failure depend on many variables such as geometry and structure of the bank and also soil properties along the bank. Bank erosion along the Ugum River is shown in Figure 10.

Figure 10. Bank Erosion, Ugum River.

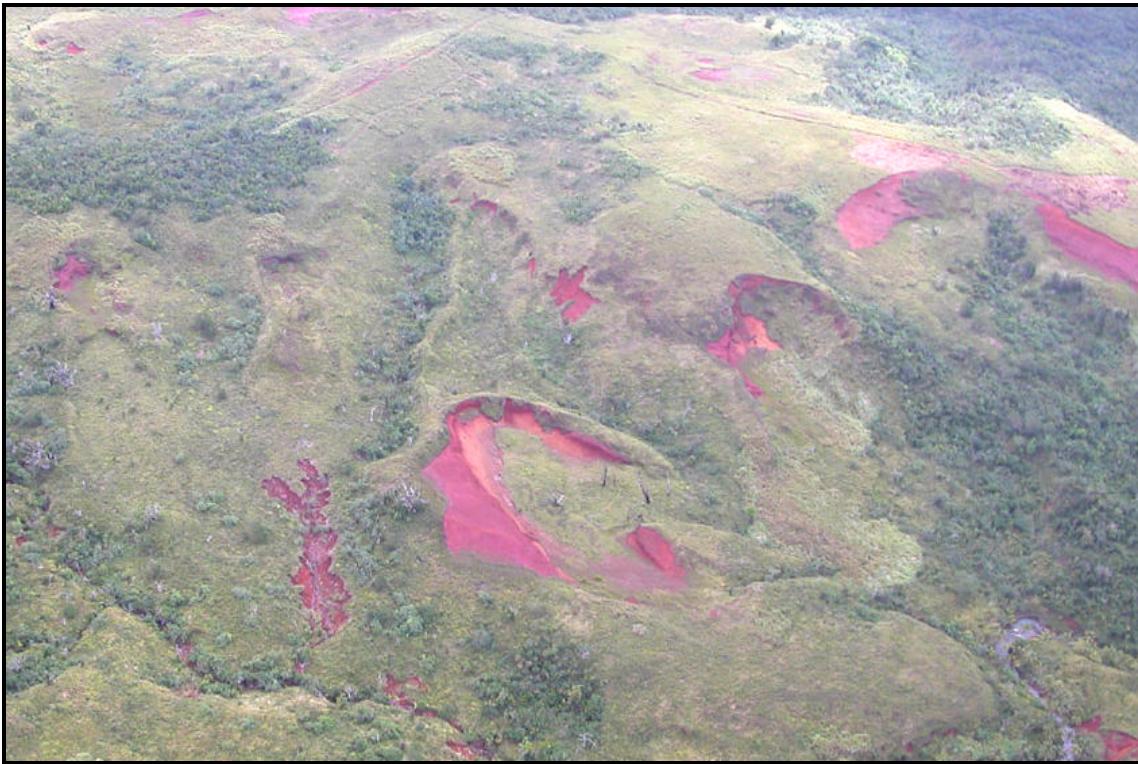
According to the digital elevation map and the aerial photography that was taken along the streams inside the Ugum Watershed, most of the slumping areas are due to the steep slope, surface runoff during heavy rainfall, and probably earth movement due to earthquakes. Figures 11a and 11b shows two land sliding sites within the Ugum Watershed.

Figure 11a. Land sliding within the Ugum Watershed.

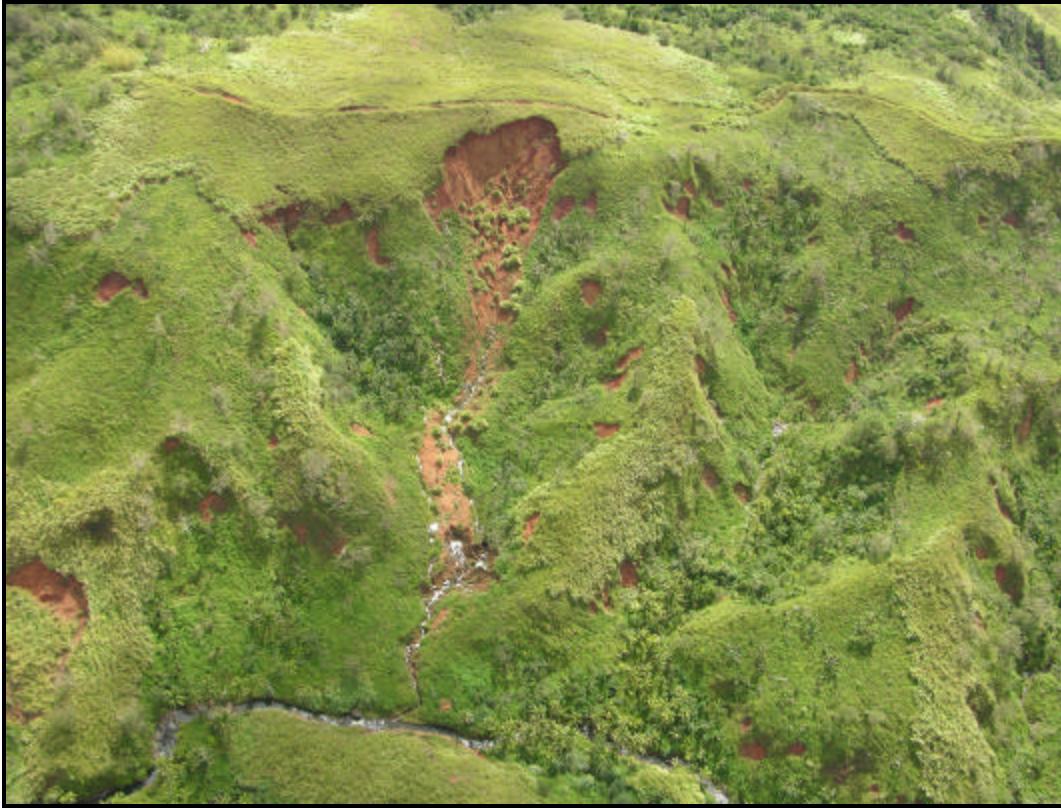
Figure 11b. Mass wasting within the Ugum Watershed.

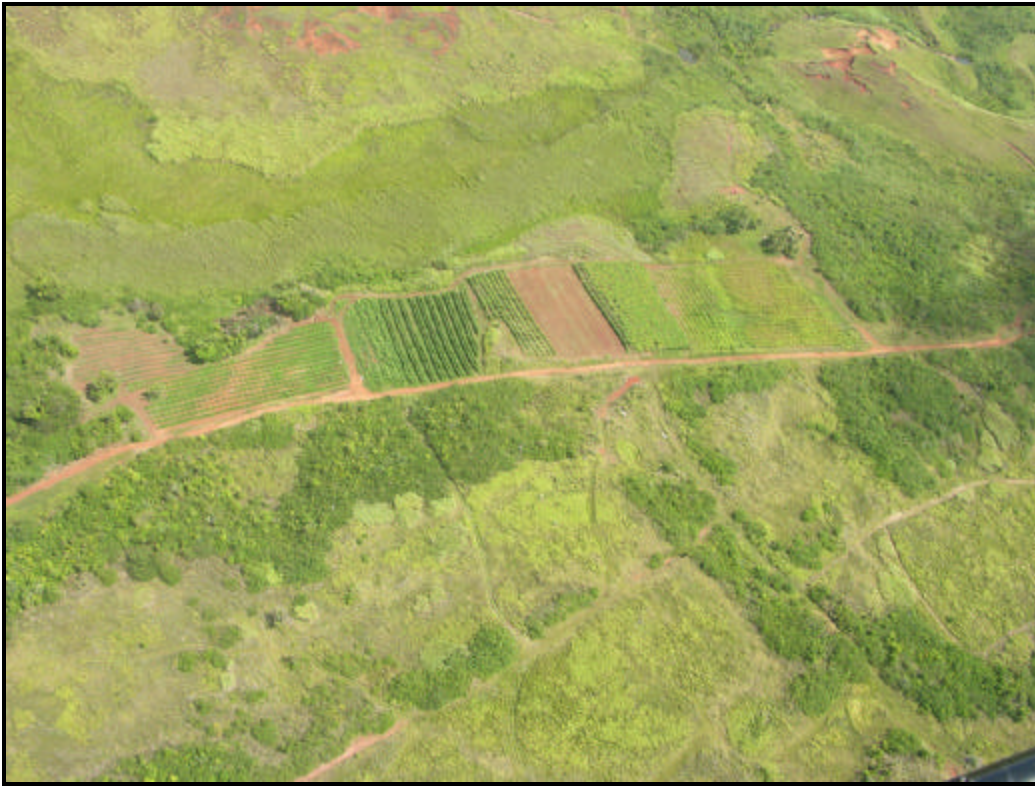
According to Department of Agriculture the impacts of the Agricultural activities on the streams are considered minor. The reason is that only small percent of the land is being used for growing plants, the activities happens only during the dry season, and the residue that is typically left on the surface at the end of dry season will protect the soil surface from erosion.

Figure 13. Farmland in the northern watershed boundary next to the Bubulao River.

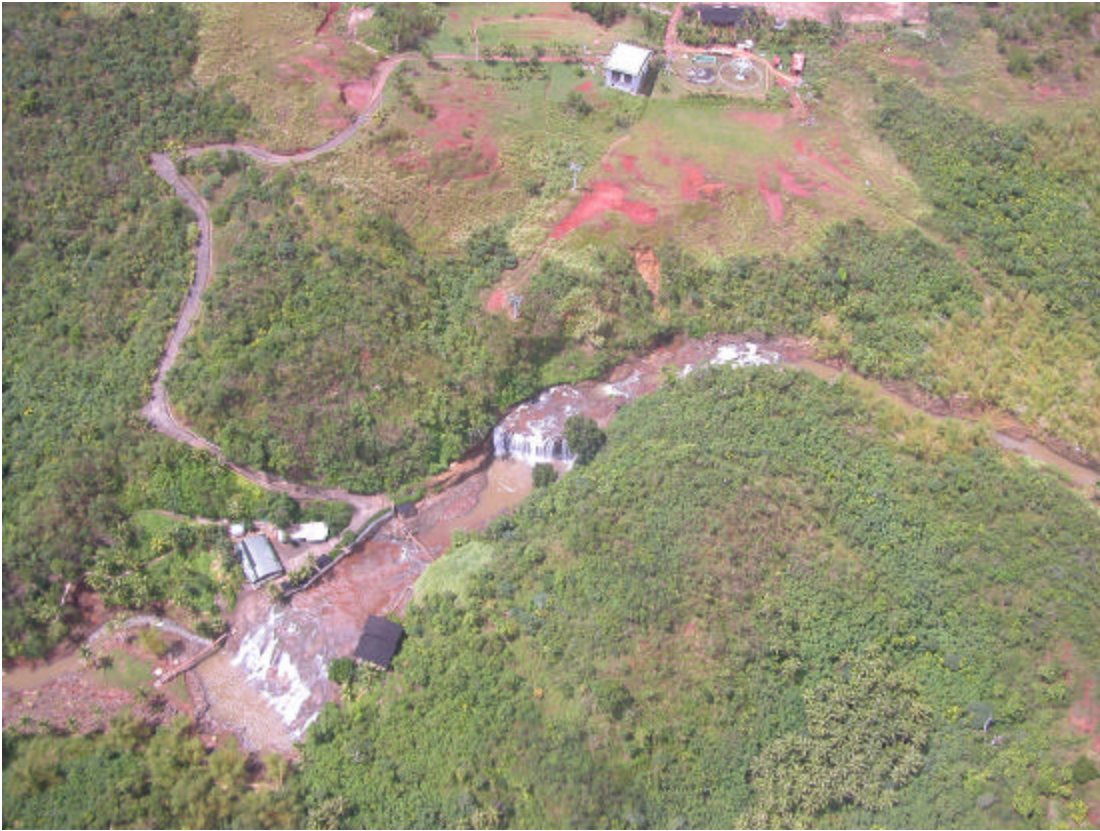
Figure 14. Talafofo falls Water Park, Ugum Watershed.

The Talafofo Falls is a 30-foot drop of the Ugum River cascading into a deep pool framed by steep bluffs and level rock ledges. Every year approximately 4,500 visitors visit the fall. The recreation area includes a paved parking lot for cars and busses, monorail to the fall and one restaurant and shop next to the fall.

The Ugum River trip has two daily boat tours up the Ugum River from Talafofo bay to share a taste of traditional Chamorro life. There used to be a Safari Tour that took tourists on jeep trails into the upper Bubulao area to view the native ravine forests and wildlife of Guam. This tour is not in operation any more. Location of the Talafofo fall is shown in Figure 14.

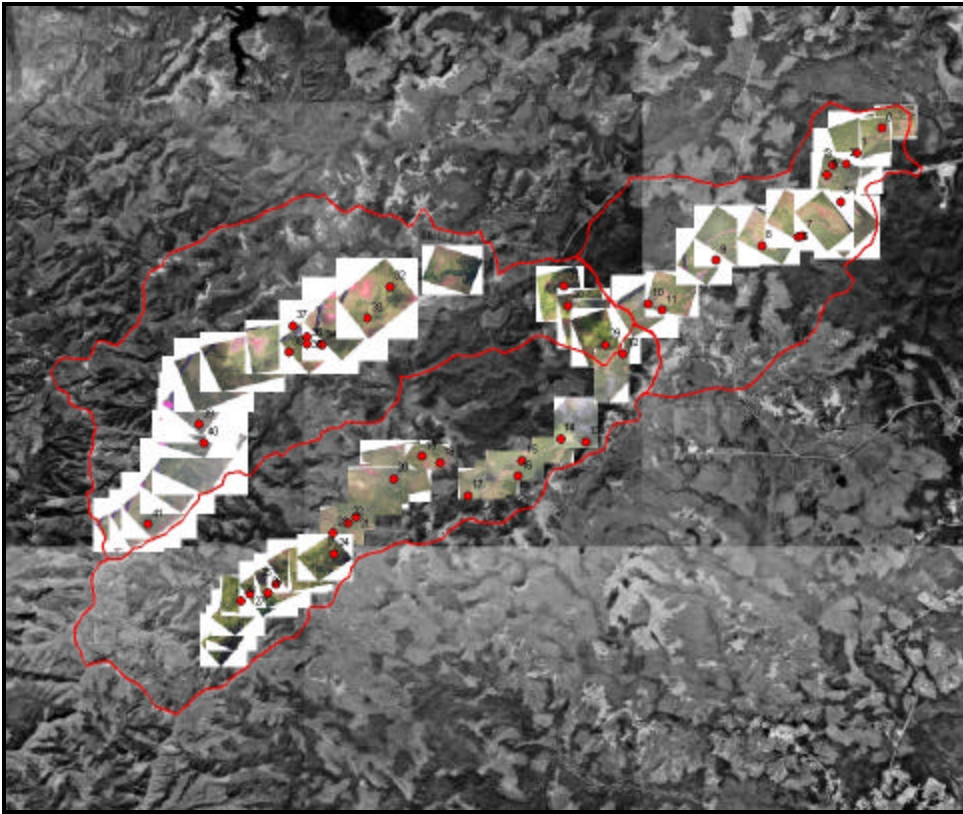
The sites that have potential to be considered as non-point sources pollution (contributing sediment particles into the streams) have been identified (marked) in the aerial photos of the Ugum and Bubulao rivers. These aerial photos, taken from helicopter runs from altitudes ranging from 1500 to 2500 feet are in the attached diskette and shown in Figure 16 and a close up is shown in Figure 17. The site selections were based on the steepness of the river section, changes in river direction, bank erosion and land slumping (observed from aerial photos). As mentioned earlier there are other sites that contribute sediment into the streams such as: badlands, off-road vehicle excursions, and sheet and rill erosion. Badlands could contribute a large amount of the sediment into the waterways. They need to be monitored and an effective re-vegetation method should be applied. The off-road vehicle excursions, and sheet and rill erosion (mostly due to intended fire) are mostly due to human activities. The public should be informed of the impacts and necessary fines should be in place.

Figure 16. Aerial Photo of the Ugum and Bubulao Rivers. Red dots are sites with potential erosion.

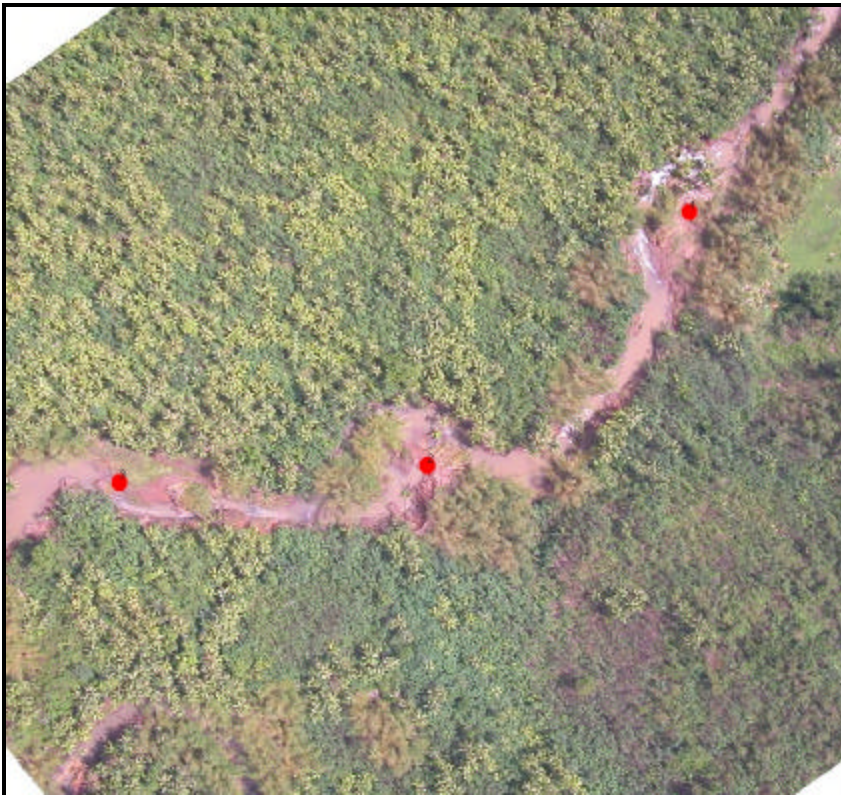
Figure 17. A close up of the sites with bank erosion.
