A PRELIMINARY INVESTIGATION OF SALT-WATER INTRUSION ON NUKUORO ISLAND, NUKUORO ATOLL, PONAPE STATE

Technical Report No. 44

Partial Project Completion Report

EVALUATION OF GROUNDWATER RESOURCES OF NUKUORO AND KUTTU ISLANDS

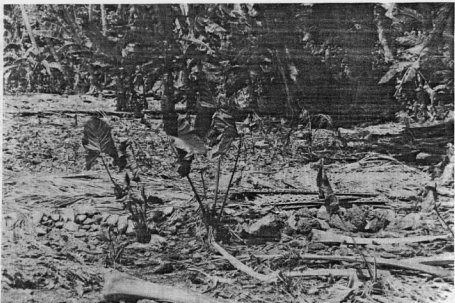
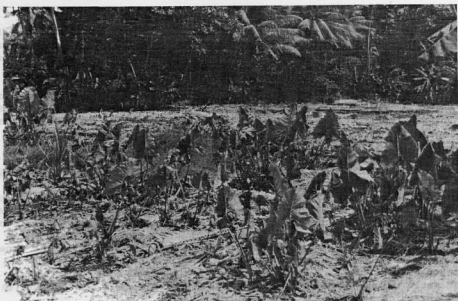
7. Healthy taro plants were observed along a number of the built-up pathways across affected areas, although not observed in the severely affected parts of the patch (for example at the southeastern end).

Taro production on Nukuoro has seriously decreased due to salt-water intrusion into the region of cultivation. The photographs in Figures 12

Figure 12. Photographs of the severely affected portion of the taro patch.

3. The refilling process should progress from the western side of the taro patch toward the most severely affected area in the southeast portion. Because the western side of the taro patch is probably underlain by fresher water, it is less susceptible to salt-water intrusion. Therefore, taro productivity would be increased in this area and the plants would be better protected against future unpredictable conditions of salt-water intrusion.

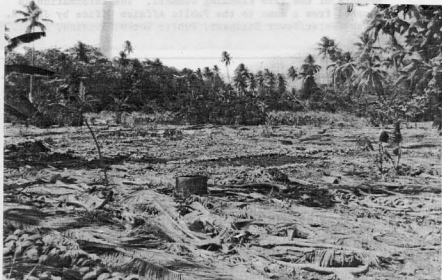
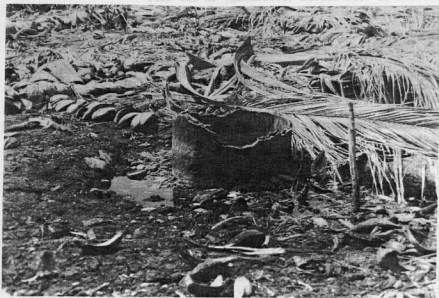
Figure 13. Photographs of severely affected area and cisterns of the taro patch.

4. A number of cisterns within the taro patch are badly deteriorated. These should be either repaired or removed completely. If they are removed, the area should be thoroughly cleaned of soil such that the reef-flat substrate is bare. The hole or fracture where the cistern was located should be completed sealed with cement or mortar so that no leakage can occur.
