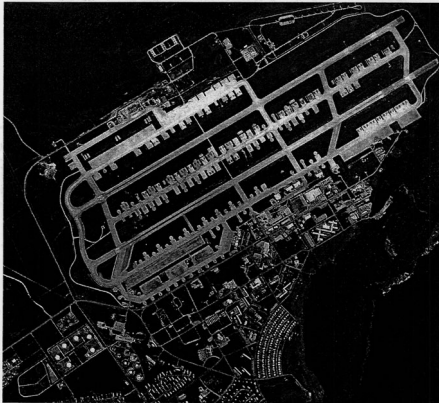
Figure 7.3. Andersen Air Force Base and its runway complex. (Courtesy: Bureau of Planning)

Andersen Air Force Base (AAFB) (Figure 7.3) is a dual runway operation with a small state-of-the-art air terminal, state-of-the-art navigation aids, and a steel-reinforced concrete 90-foot control tower. Air field navigation aids are vulnerable to damage by strong winds (medium-strong Typhoon Category 3 or higher) and flying debris. The Air Traffic and Approach Control system (CERAP), air field navigation aids, and air field lighting are all served with emergency power from back-up generators.

There are several hangers at AAFB, which can house the helicopters of the Navy's HC-5 Squadron and aircraft that aren't able to fly. Since most aircraft on Andersen are transient, they are generally evacuated when sustained winds are predicted to be 50 kt (57 mph) (Tropical Storm Category B) or greater. Those unable to fly are placed in hangers. The doors and the windows of the hangers are vulnerable to damage when winds reach weak Typhoon Category 4 intensity.

AAFB has some on-base generators that can be activated if island power is lost. It also has some water wells with emergency power back-up. Most power poles on the base are solid steel-reinforced concrete, and most will stand up to weak to medium Typhoon Category 5 winds. Most primary lines will stand up to medium Typhoon Category 4 winds, while many secondary lines are vulnerable to weak to medium Typhoon Category 3 winds (see Tables 8.1 and 8.2). The base also has several fuel storage tanks containing several million gallons of jet fuel. These could be vulnerable to medium-strong Typhoon Category 5 winds (see Table 8.3).

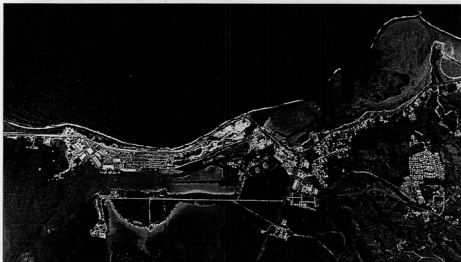
**Figure 7.4. Apra Harbor and the Commercial Port at Cabras Island. (Source: Bureau of Planning)**

Seaport facilities include the Commercial Port and the US Naval Activities, both located at Apra Harbor. The two facilities share a common outer harbor. The Commercial Port is at the eastern extent of Outer Apra Harbor (Figure 7.4), and is poorly protected. The US Naval port is located in Inner Apra Harbor (Figure 7.5). The inner and outer harbors

are connected by a channel that passes between the Ship Repair Facility (west) and Polaris Point (east). Apra Harbor has a single, relatively narrow deep-water channel linking the open ocean to port facilities located at the eastern end of the harbor. This channel is critical to the movement of large ships in and out of the harbor. **Were a large ship to sink in the channel, it could take up to 6 months to salvage it and fully reopen the channel.** This could greatly limit the use of the port, and could produce a devastating impact to the Island. For this reason, all large ships should leave the harbor before the onset of 35 mph winds when a typhoon is expected. **A second deep-water channel may be needed inside the harbor.** If winds reach strong Typhoon Category 2 intensity, they could cause a large ship to break or drag anchor, possibly endangering the channel.

Guam's Commercial Port is located at Cabras Island (Figure 7.4). It is the busiest US port in the western Pacific, comparable in container traffic to Portland, Oregon. Nearly 100,000 containers are handled annually. It is the major transshipment center for the Mariana Islands and for much of Micronesia. The port can handle ships with a draft of over 32 feet.

The Port facility contains three rail-mounted gantry cranes for off-loading containers from ships. It also has two large rubber-tired strike cranes and one mobile strike crane for handling containers within the large container yard capable of storing several thousand containers. The cranes are vulnerable to strong winds. While they have complex braking systems and can be tied to the wharf area, winds of strong Typhoon Category 4 intensity can begin to twist/torque the upper arm structure of the cranes. Considerable damage is likely to occur to the cranes when winds reach Typhoon Category 5 intensity.

The rubber-tired cranes are susceptible to rolling in Typhoon Category 4 winds and probably tipping in Typhoon Category 5 winds.

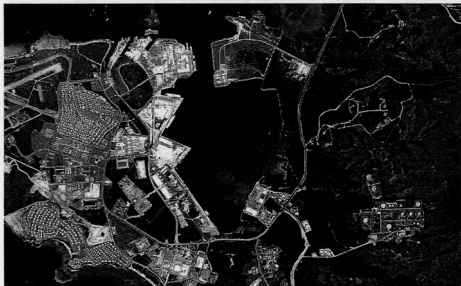
Figure 7.5. US Naval port complex at Inner Apra Harbor. (Courtesy: Bureau of Planning)

The US Naval Activities Guam is located on Orote Peninsula, which forms the south border of Outer Apra Harbor and the west side of Inner Apra Harbor (Figure 7.5). The wharves and primary port facilities are located on the west and southeast sides of the harbor.

The infrastructure on Naval Activities is not as well developed as that at Andersen Air Force Base. The power infrastructure contains a substantial number of wooden poles, which are susceptible to being blown down or broken by weak to medium Typhoon Category 3 or higher winds. It also contains a large number of solid concrete steel-reinforced power poles, which can probably endure sustained winds of at least medium Typhoon Category 5. Most primary lines are on the hollow-spun concrete poles and will stand up to medium Typhoon Category 4 winds. Many secondary lines are on wooden poles and are vulnerable to weak to medium Typhoon Category 3 winds. The Navy also has several fuel storage tanks containing several million gallons of fuel. These could be vulnerable to winds of Typhoon Category 4 and 5, as discussed in Section 8.3.6 and Table 8.3.

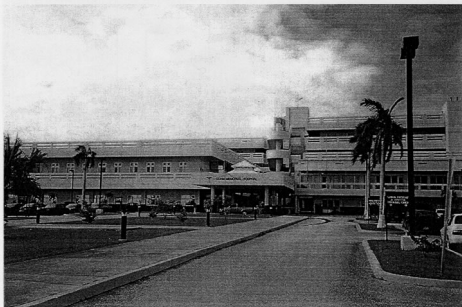
Figure 8.4. Guam Memorial Hospital.

The Guam Memorial Hospital (GMH) (Figure 8.4) and the US Naval Hospital are the two primary medical facilities on the island. Both of these facilities are susceptible to damage from wind, blowing debris, and especially rain. Some damages occurred during both Typhoon Omar and Typhoon Paka, but most damage was due to water leakage. Both facilities would suffer considerable damage during a typhoon with winds of Typhoon Category 5. The sliding glass doors of the GMH are especially vulnerable to being blown in. During Typhoon Paka, GMH had damages amounting to \$1 million.

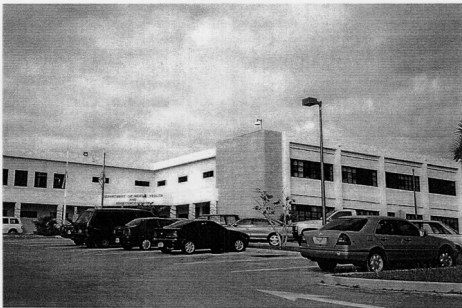
Figure 8.5. Example of a Clinic: Department of Mental Health and Substance Abuse.

There are several clinics on the island. These range from the clinic at Andersen Air Force Base, to the five clinics of Public Health (Mangilao, Dededo, Santa Rita, Tamuning, and Inarajan), and the clinics of private health maintenance organizations (e.g., FHP, Seventh-Day Adventist, GMHP). Figure 8.5 shows the Department of Mental Health and Substance Abuse Clinic in Tamuning. Damages to Public Health facilities during Typhoon Paka amounted to about \$930,000.

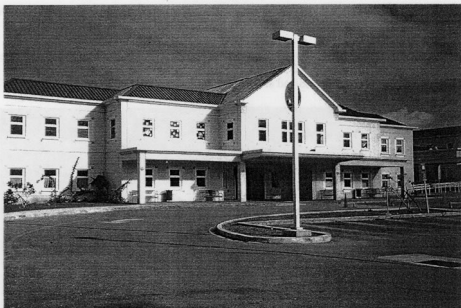
Figure 8.6. Public school: Tamuning Elementary.

During Typhoon Paka, Piti Middle School lost its entire roof and many schools had serious roof damage. Total damages to Department of Education facilities amounted to \$17 million, including centralized administrative facilities.

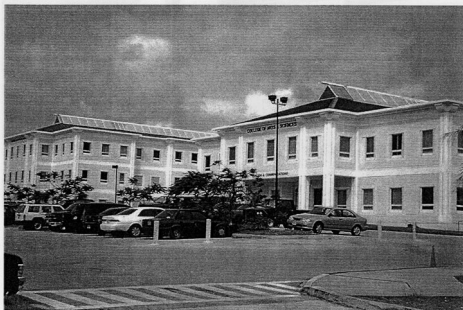
Figure 8.7. The Humanities and Social Sciences Building (left) and the English and Communications Building (right) of the College of Arts and Sciences at the University of Guam.

Historically, the biggest problem for University of Guam (UOG) buildings has been water damage due to leakage. However, the buildings at the UOG have not been subjected to winds stronger than moderate to strong Typhoon Category 3. It is likely that many windows and doors will not hold up to winds of strong Typhoon Category 4, and damage will be heavy with winds of Typhoon Category 5 intensity. The strongest and most survivable building at UOG is the Field House. However, it would receive significant water damage during typhoons of Typhoon Category 4 and Typhoon Category 5. During Typhoon Paka, strong Typhoon Category 3 winds blew out a small upper wall of the Science Building. Figure 8.7 shows some of the newer buildings on campus. The roofs connecting the concrete buildings would likely incur heavy damage in Typhoon Category 4 or stronger winds.

Damage from Typhoon Paka was widespread on the campus. Many air conditioners were blown out and water damage was common. The cost of damages was \$7.5 million. Guam Community College also had about \$600,000 in damage.
