**SPATIO-TEMPORAL  
DYNAMICS OF BADLANDS  
IN SOUTHERN GUAM:  
A CASE STUDY  
OF SELECTED SITES**

**WATER AND ENVIRONMENTAL RESEARCH INSTITUTE  
OF THE WESTERN PACIFIC  
UNIVERSITY OF GUAM**

**Technical Report No. 133**

**September 2011**

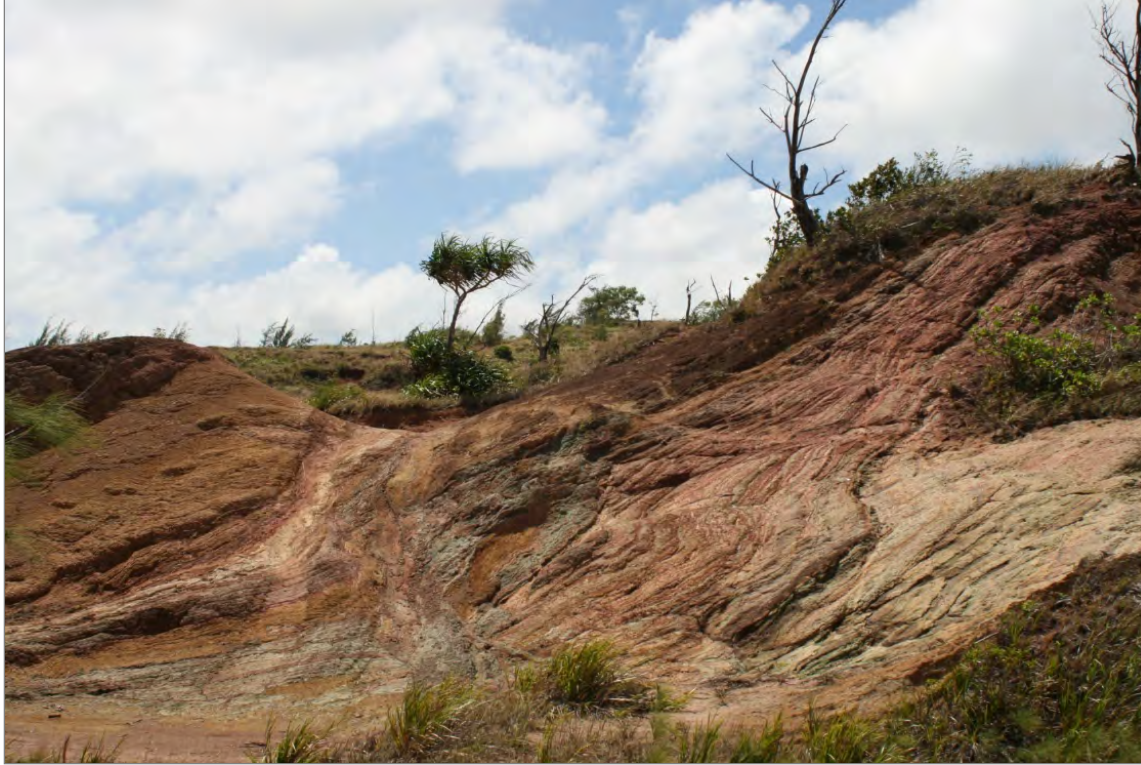
**Figure 1.** Picture of a badland where saprolite is exposed. Note the original structure of the bedrock that is preserved in the saprolite despite weathering.

Saprolite is a soft, usually clay-rich, thoroughly decomposed rock that formed in place by chemical weathering of rock while retaining its original structure (Figure 1); in humid and tropical climates, saprolite can reach 100 meters in depth (Neuendorf *et al.*, 2005). Original rock minerals are replaced by clay minerals through leaching. Clay particles are then subject to a shrink-swell mechanism, which is especially pronounced in climates with high temperate, rainfall, and alternating wet and dry periods (Doerge and Smith, 2008) like on Guam. The shrink-swell mechanism forms soil aggregates, which are easily erodible (Gavenda, 2009). Saprolite is also strongly acidic and nutrient poor, creating a hostile environment for most plants. Badlands usually form on heavily eroded Akina and Atate soils (Young, 1988).

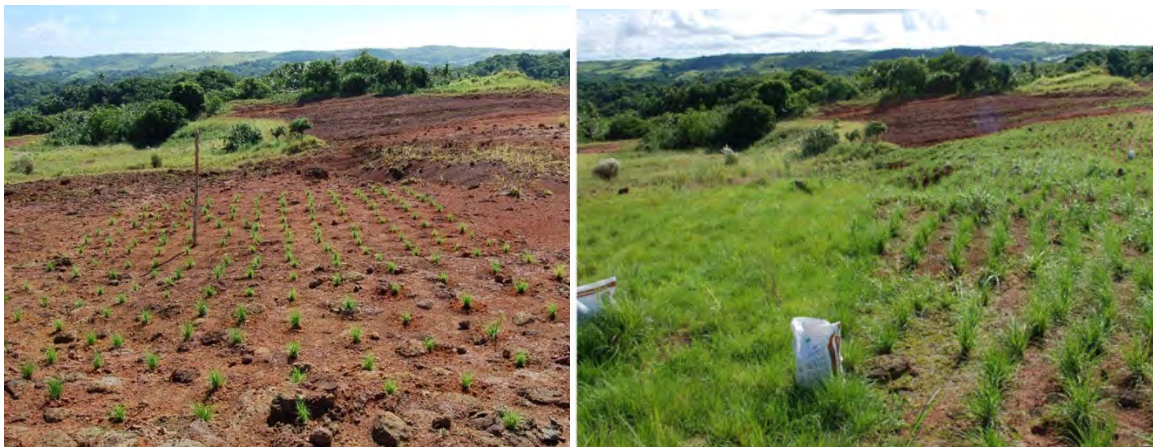
**Figure 2.** Restoration of badlands at the Naval Ordinance. Photos show badland with newly planted vetiver grass (left) and restored badland (right). *Photos courtesy of Dr. Anne Brooke, U.S. Navy.*

Re-vegetation is costly and time-consuming, but attempts on a small scale have been made by several agencies on Guam. The Navy has successfully restored some badland areas in the Naval Ordinance around Fena Lake as shown in Figure 2 (Grimm, 2009). The National Park Service planted vetiver grass and sun hemp on test plots in the Asan Park a few years ago to evaluate their suitability for re-vegetation (Coffmann, 2010). Before the plants were fully established, the plots were vandalized, and the project then stopped. The Guam Department of Agriculture has planted many Acacia trees in badland areas in the Ugum Watershed in 1998 and in the Cotal Reserve in the Tarzan area to reduce erosion. The non-native Acacia trees have established but will be replaced by native trees such as *Calophyllum inophyllum*, *Cerbera dilatata*, and *Pandanus tectorius* in the near future (Crago, 2005). The Natural Resources Conservation Service (NRCS) successfully planted bahia grass and vetiver grass on bare saprolite (Doerge and Smith, 2008). All successful re-vegetation efforts required soil amendments (e.g., increasing organic matter) because of the extremely poor soil quality of the badlands in southern Guam.

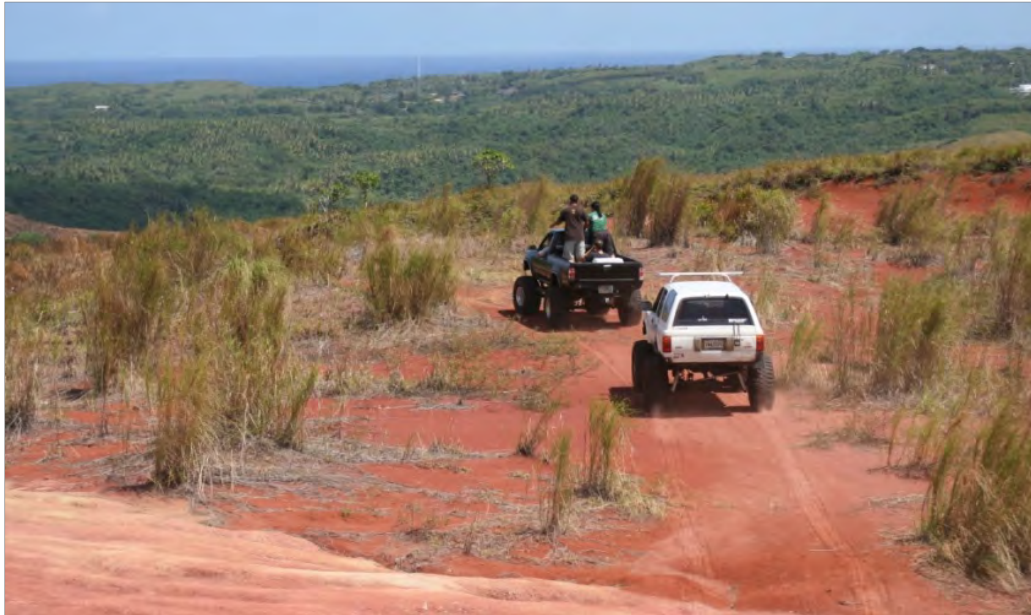
then veers off to the west into the Tarzan sub-basin. Off-roading is very popular in this area likely because of its easy access. A large network of tracks on the western half of the study site connects major badland areas. Most of these badlands are highly eroded with deep gullies. Most gullies observed in this area are likely the result of frequent off-road vehicle (ORV)-use.

**Figure 11.** Off-roaders at the Yona study site.

A small section is zoned hotel, which belongs to the Windward Hills Country Club (before 1995 called the Takayama Golf Club), the oldest golf course on the island, which opened in 1951. The golf course extends beyond the study site to the southeast. Another golf course was planned at the study site in the early 1990s. A gravel road was already built when the project was stopped due to the economic downturn in Japan. This road is about two kilometers long and stretches from Route 17 across the study site to Ylig River. Most of the now dirt road is still visible on current satellite imagery. The western part of this study site is a popular recreational area for hikers and off-roaders (Figure 11). The trail to the Tarzan Falls starts on the study site but

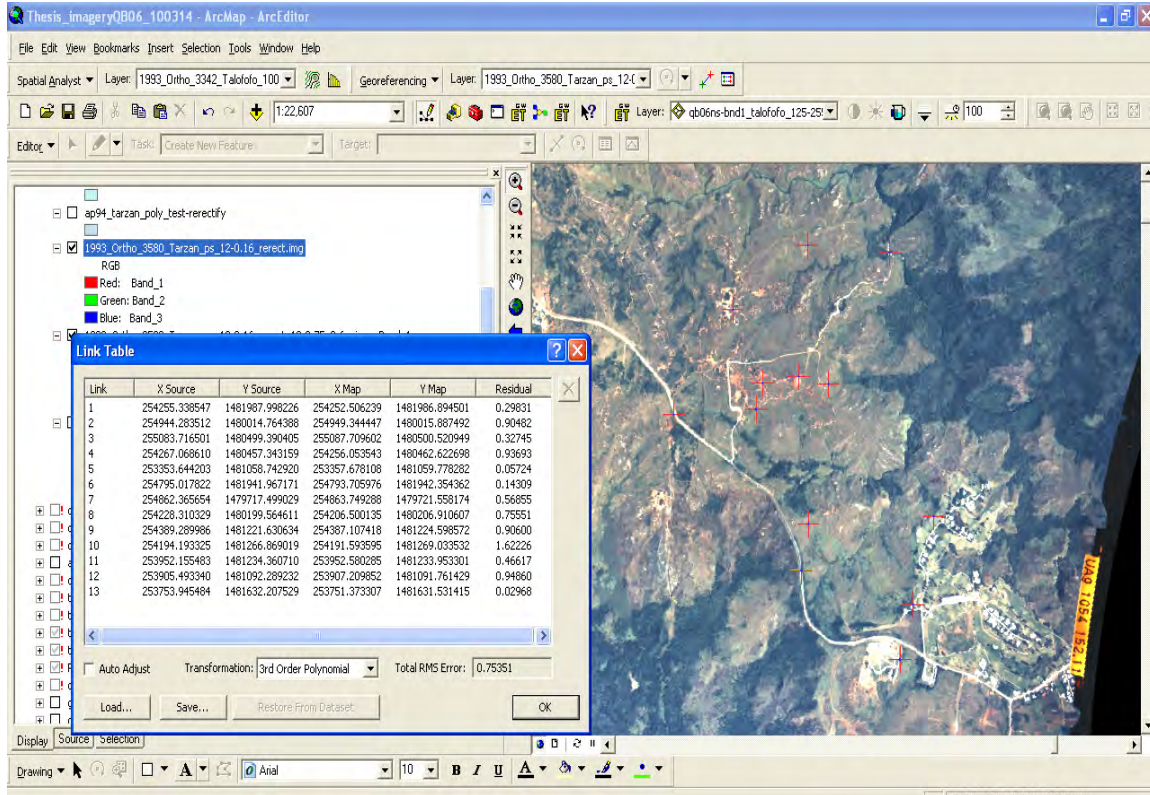
**Figure 16.** Screen shot of the georeferencing process. The link table displays the map and source location of the control points with the individual residual error and also the total root mean square error. A third-order polynomial transformation was used here.

Erroneously linked GCPs may produce a high total root mean square error (RMSE). To reduce the overall error, GCPs with a high residual RSME were removed in the link table (part of the georeferencing tool) and new ones were added. This process was repeated until enough (minimum of 11) well distributed GCPs were established and the total RSME was acceptable.

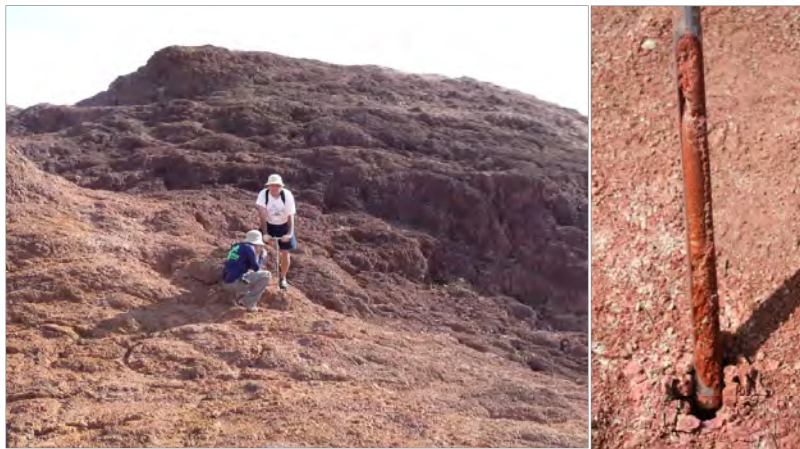
**Figure 20.** Researchers collecting soil samples with a soil probe in the field.

A minimum of three composite samples (CS) from two badlands and one adjacent savanna were collected with a soil probe from each study site (Figure 20). The samples were taken from 0–15 cm (0–6 inches) and 15–30 cm (6–12 inches), respectively. The location of each sample was recorded with a Garmin Global Positioning System (Figure 21). Each CS comprises five individual soil samples that were taken from the same patch (approximately 5–10 m apart). Each CS was divided into two Ziploc bags with respect to the depth sampled. The bags were then sealed and taken to the University of Guam soil lab for analysis. A total of 22 samples were collected.

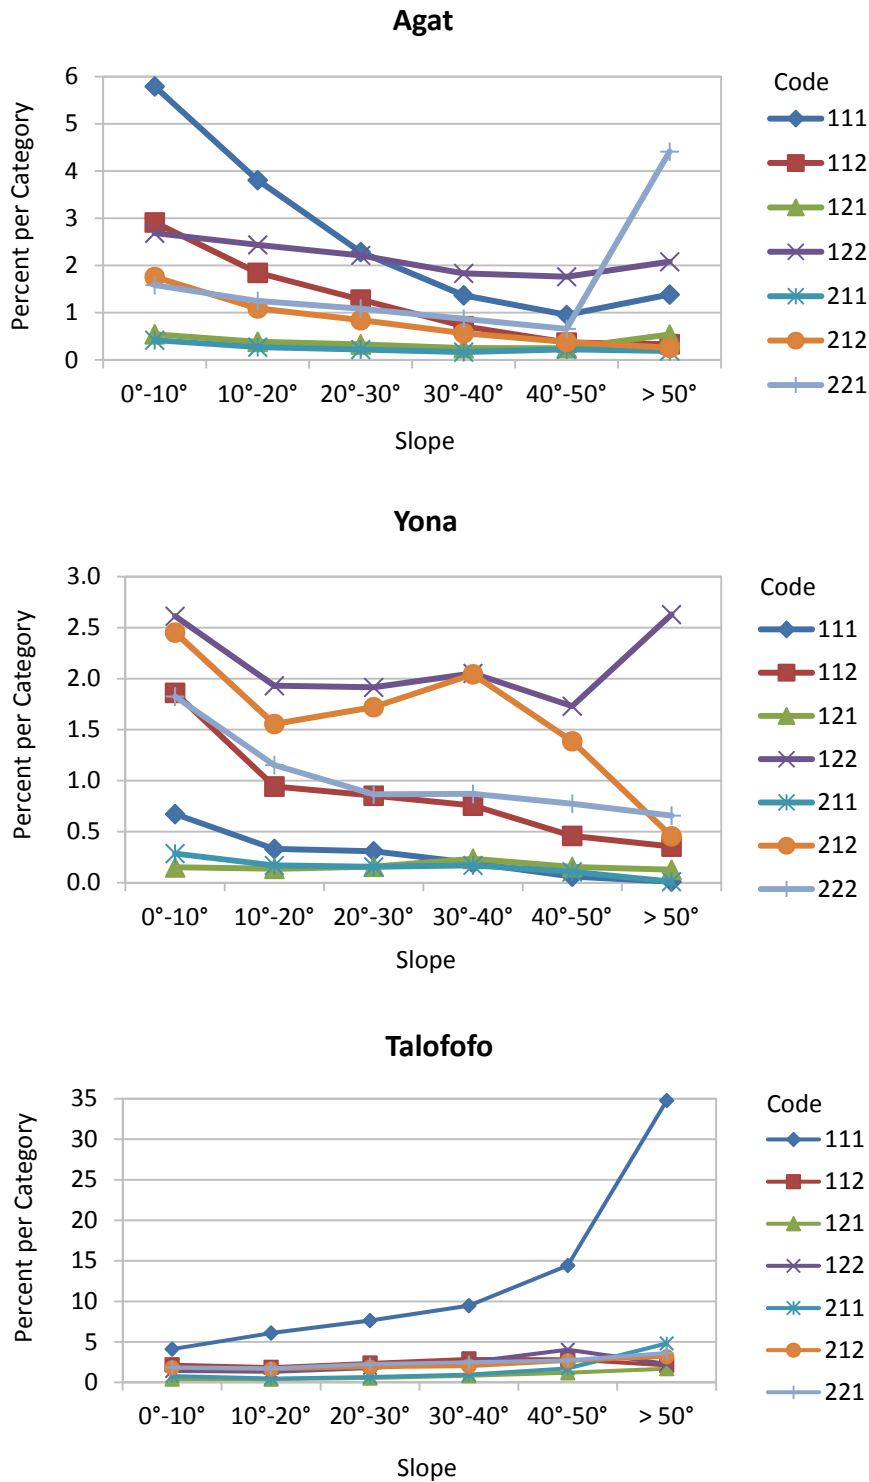
**Figure 28.** Proportional abundance of badland change classes per slope category for Agat, Yona, and Talofoto. Areas that were never badland (Code: 222) are not included here.

The results of the slope analysis, when broken down by change detection classes, are presented in Figure 28. For comparison, the results in Figure 27 were based only on the badland extent in 1946 (Code: *111*, *112*, *121*, and *122*). The proportional abundance of the change detection classes at each study site generally corresponds to the trends presented in Figure 27. Change detection classes show a continuous decrease in proportional abundance with increasing slopes up to 50 degrees and a slight increase in abundance on slopes greater than 50 degrees. In Talofoto, all classes increase almost linearly in abundance on slopes between 10 and 50 degrees. Similarly, in Yona, the relationship of slope and the different change detection classes is generally negative but the trend is not as consistent as in Agat.

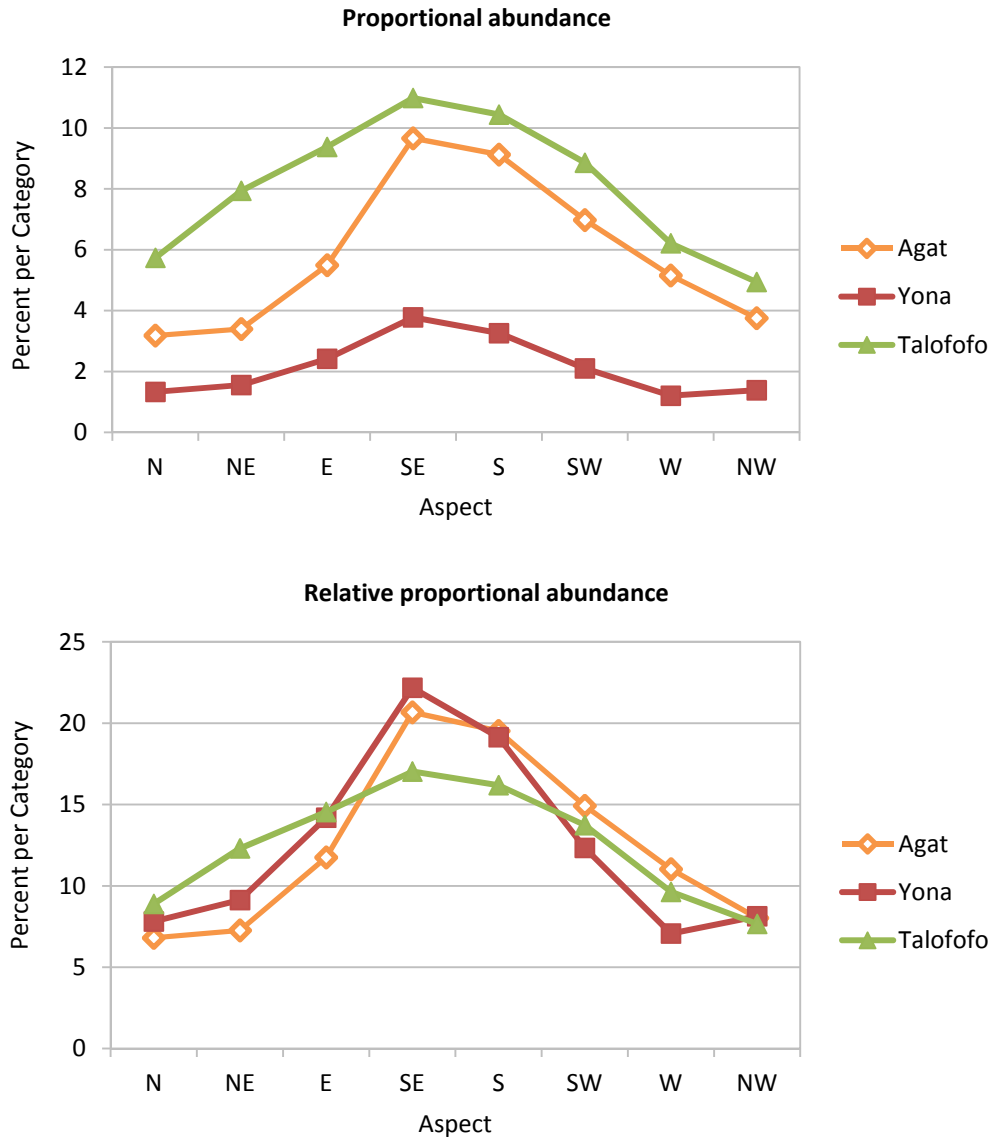
**Figure 30.** Proportional abundance and relative proportional abundance of badlands in 1946 at each study site broken down into eight aspect categories (north, northeast, east, southeast, south, southwest, west, and northwest). The relative proportional abundance normalizes the proportional abundance to allow better comparison of the study sites.

The results of the aspect analysis when broken down by change detection classes are presented in Figure 31. For comparison, the results in Figure 30 were based only on areas that were badland in 1946 (Code: *111*, *112*, *121*, and *122*). The proportional abundance of the change detection classes at each study site generally corresponds to the results presented above (Figure 30). However, some variances occur at each study site. For example, the proportional abundance of new badlands (Code: *122*) is highest on northeast-facing slopes in Agat and Yona and on southwest- and west-facing slopes in Talofof. Also, other badland classes in Talofof (Code: *112*, *121*, *212*, and *221*) peak at south- or southwest-facing slopes. The slightly different trends of badlands that developed in Yona and Talofof after 1946 could be attributed to land use, which may mask the influence of aspect on badland occurrence. In Agat, the almost reverse trend may be due to the direction of tropical storm Tingting, which passed northeast of Guam and caused many landslides. Clear trends of other badland categories, *e.g.*, badland areas that re-vegetated, could not be detected. In general, despite some variances, the fairly uniform increase and decrease of proportional abundances of badlands with changing aspect strongly suggest that aspect has an impact on badland development.

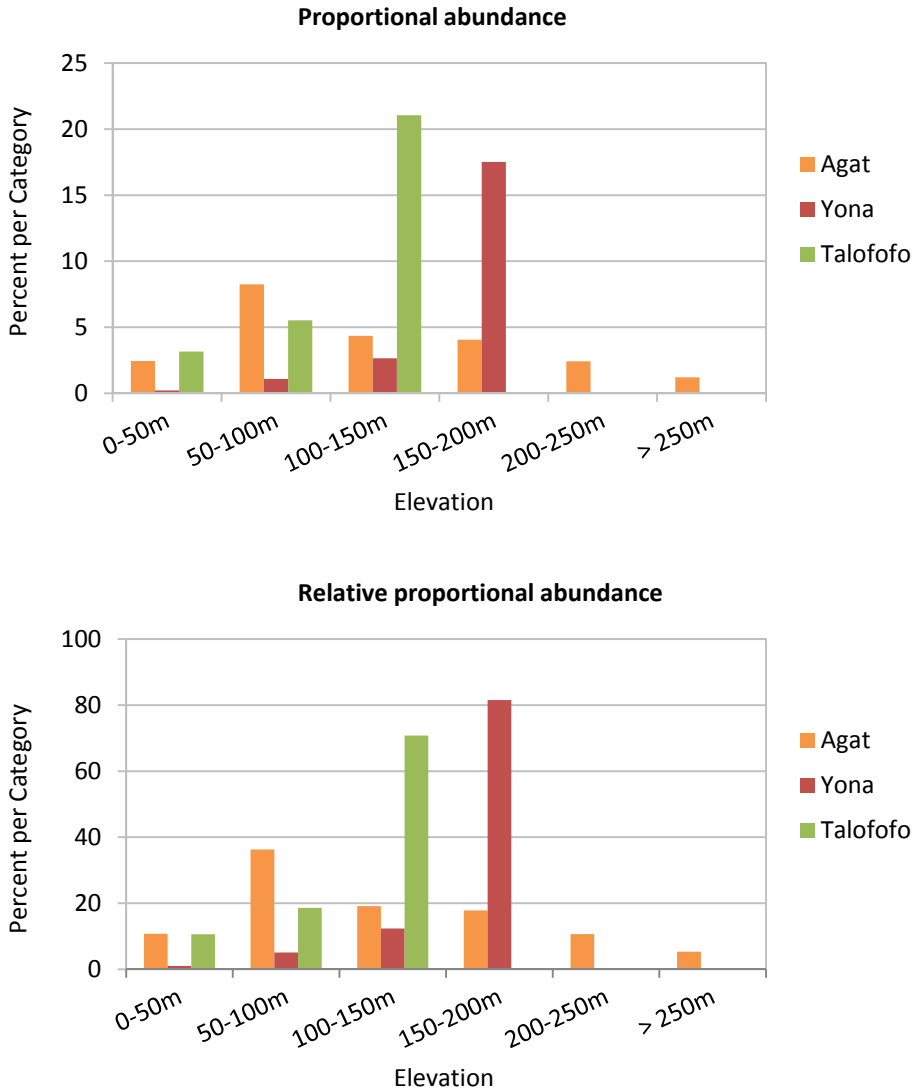
**Figure 32.** Proportional abundance and relative proportional abundance of badlands in 1946 at each study site broken down into seven elevation categories. The relative proportional abundance normalizes the proportional abundance to allow better comparison of the study sites.

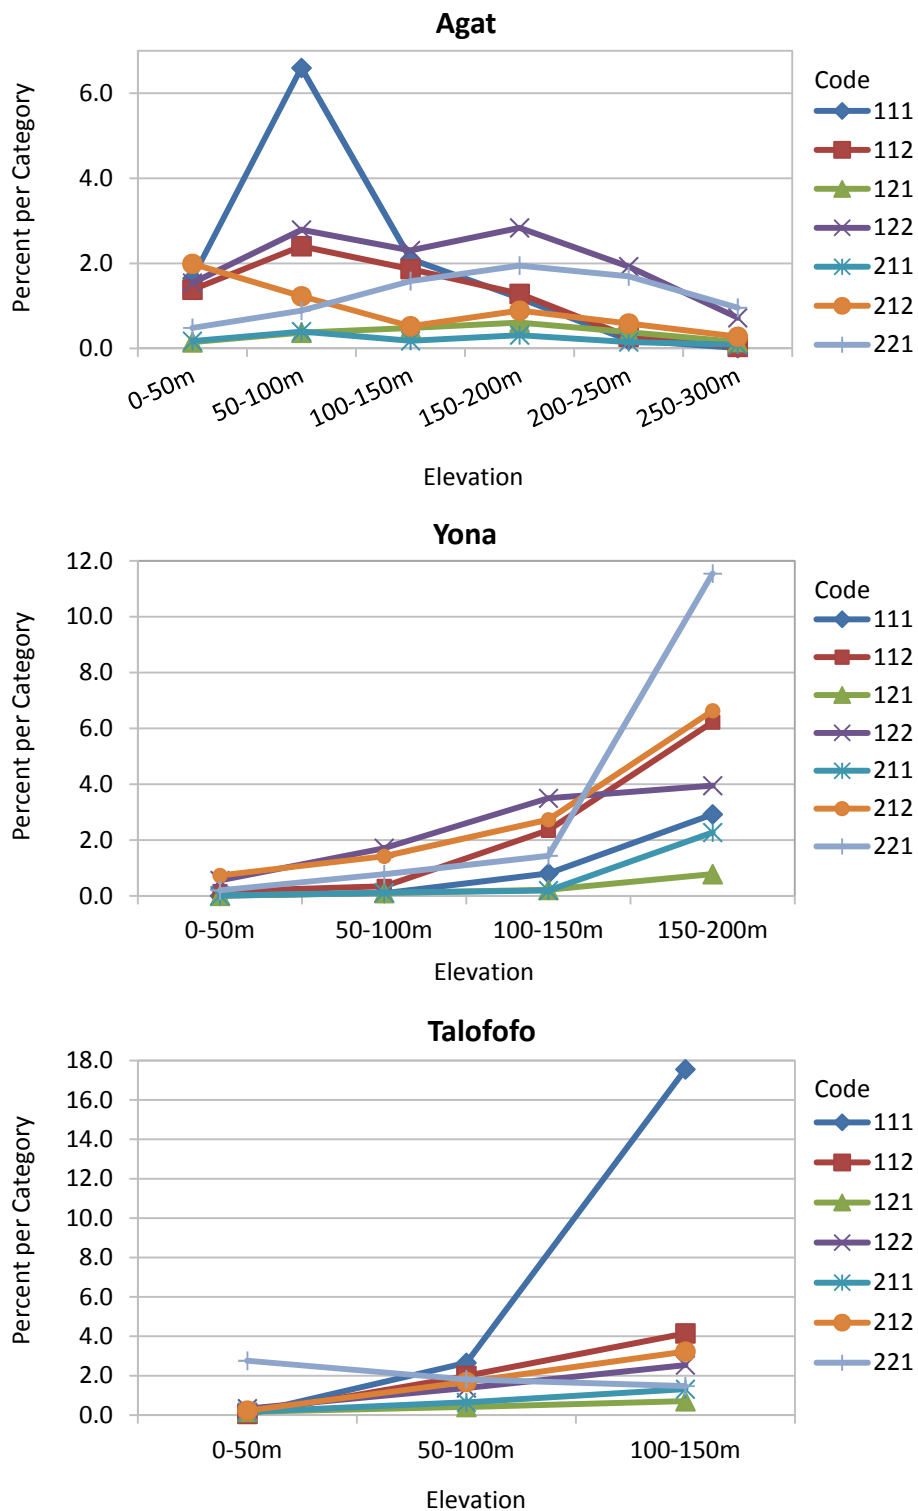
**Figure 33.** Proportional abundance of badland change classes per elevation category for Agat, Yona, and Talofoto. Areas that were never badland (Code: 222) are not included here.

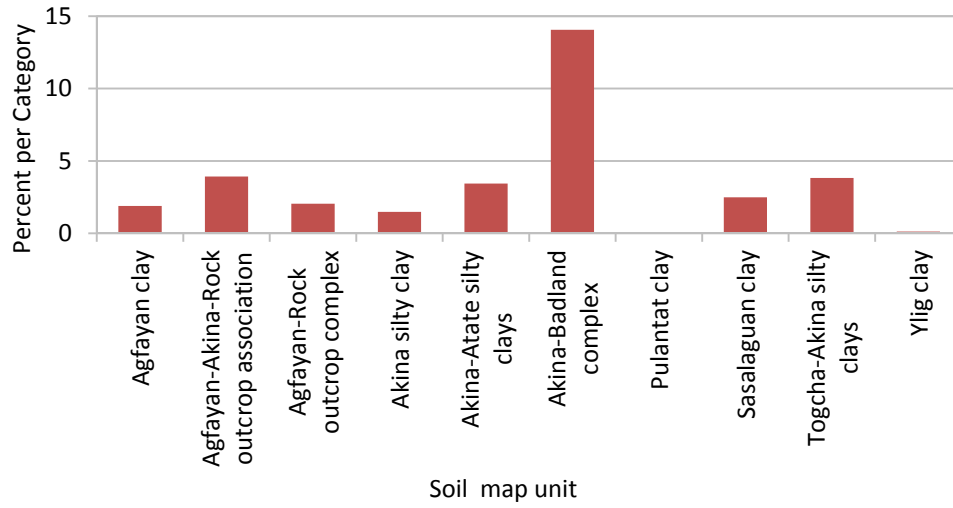
**Figure 34.** Proportional abundance of badlands in 2006 per soil category at a. Agat, b. Yona, and c. Talofoto study site. Only categories that are represented at each site are included here.

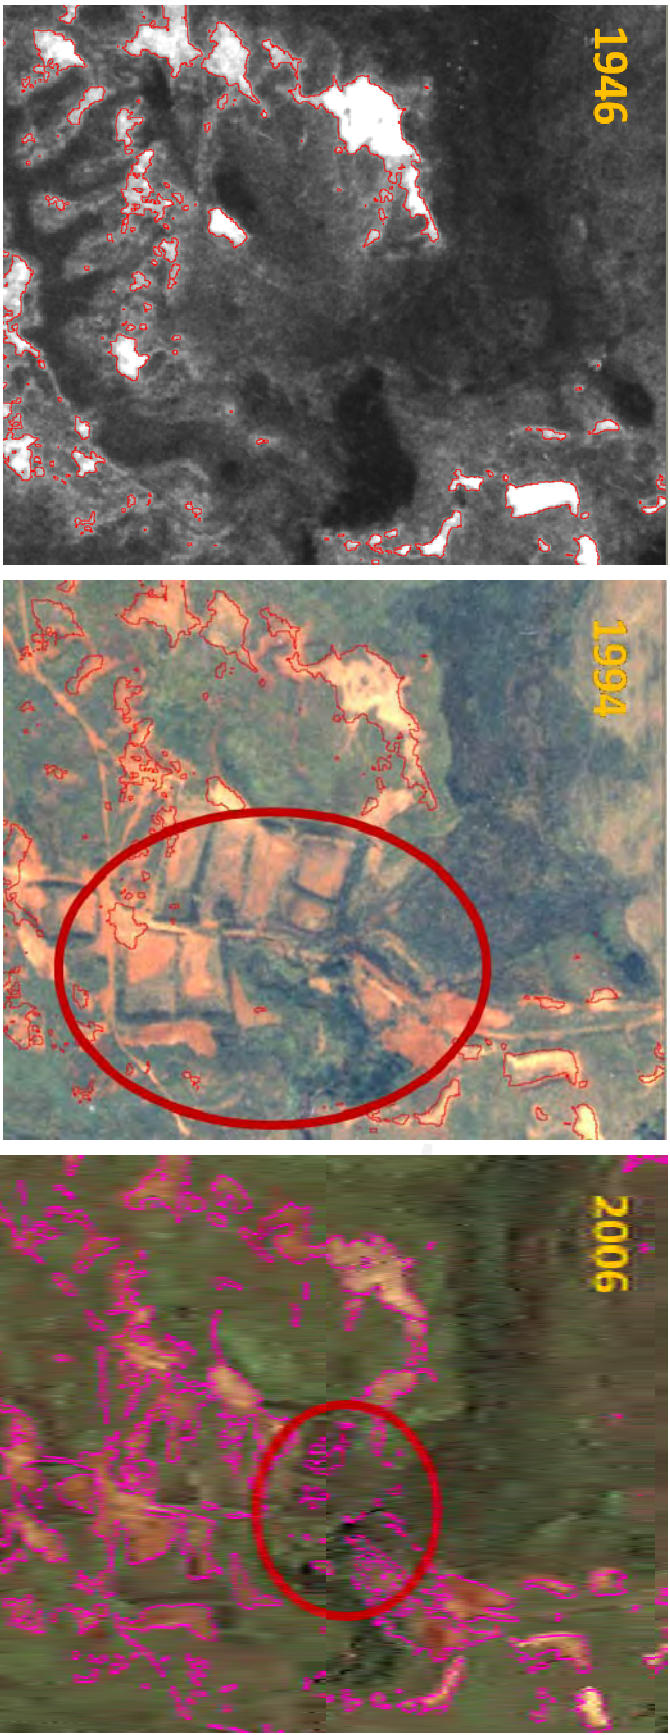
Area at the Talofoto site where abandoned farm fields or mis-managed framing likely caused badland expansion (center). Some areas were able to re-vegetate by 2006 (right). Red outlines show the 1946 badland extent; the pink outline show the 1994 badland extent.

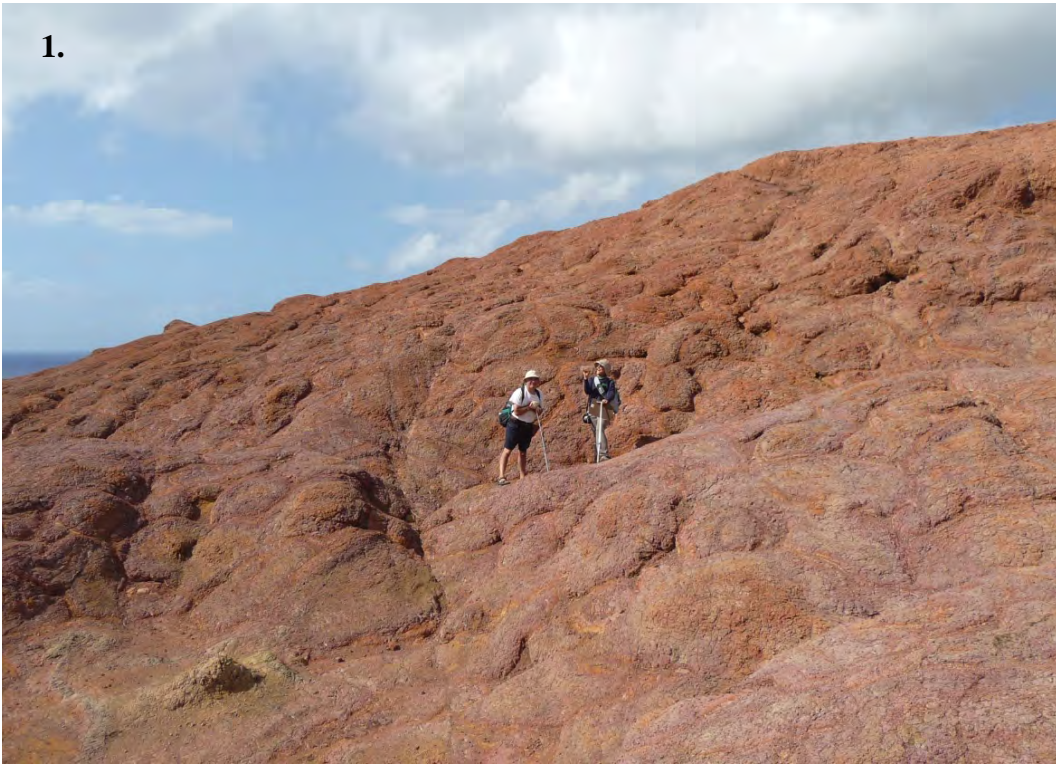
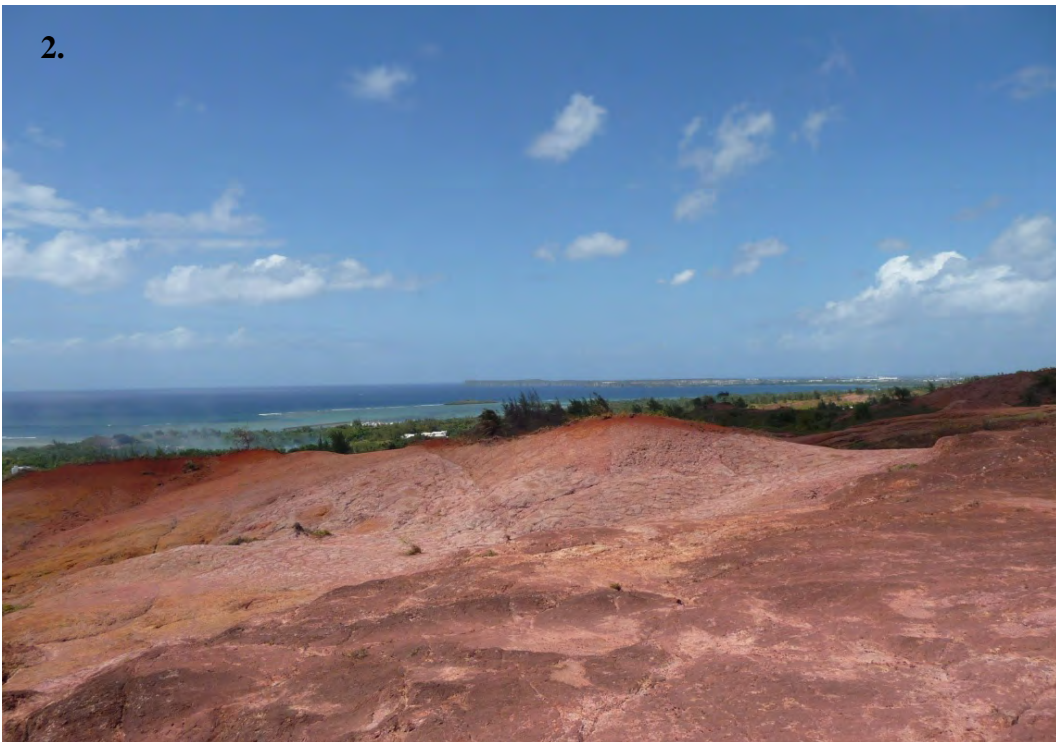
**Photo 1.** Weathered pillow basalt exposed in badland. **Photo 2.** Relatively flat badland area typical for this study site.

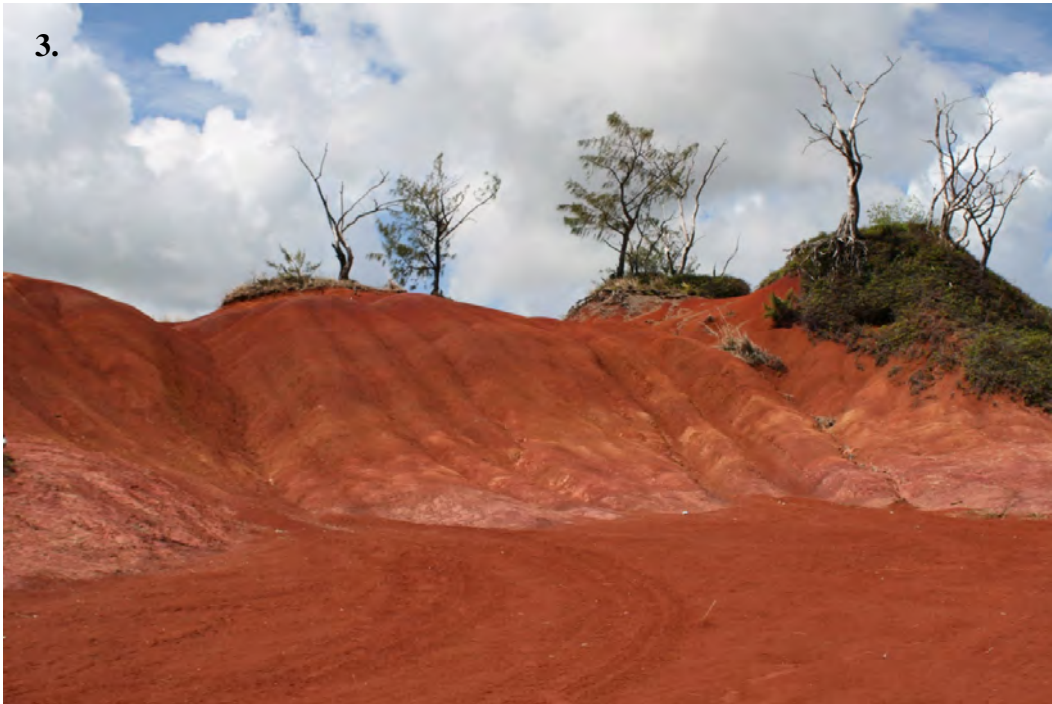
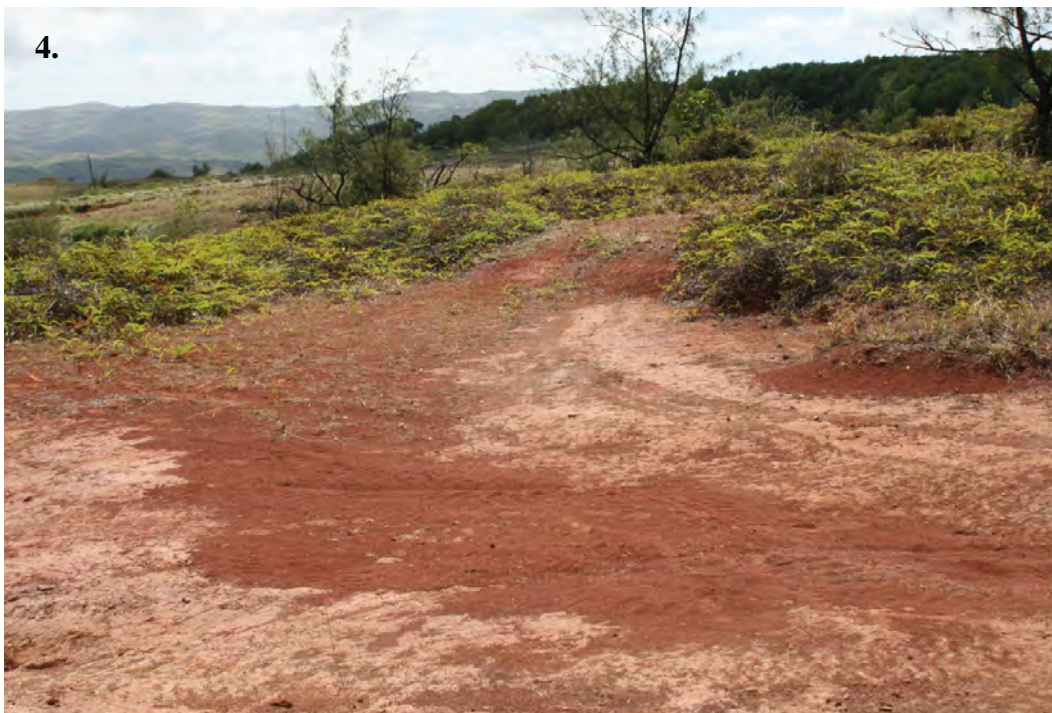
**Photo 3.** Popular off-roading area (note the tire marks) where sediments accumulate downhill. **Photo 4.** Natural re-vegetation of mostly *Dicranopteris linearis* (*false staghorn fern*) in areas where sediments accumulate (bottom).
